BUILDING INSPECTION REPORT

(ADDRESS)

Tuesday, November 19, 2019

Mayo Home Inspections, LLC

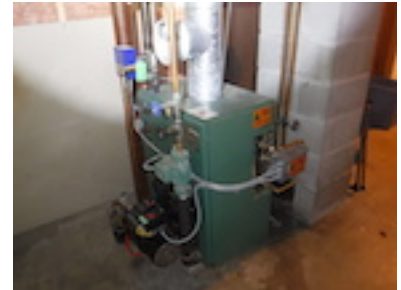
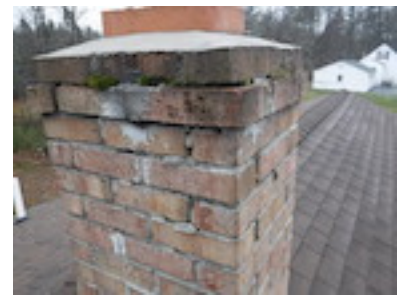
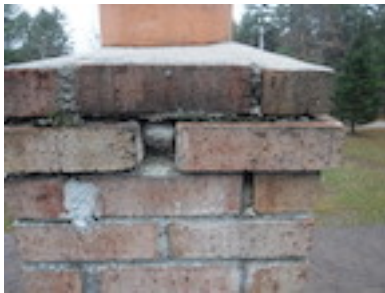
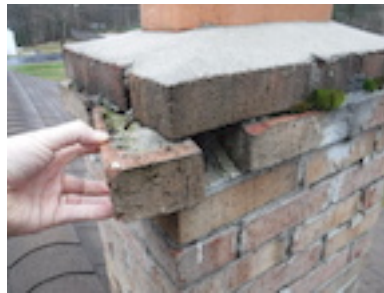
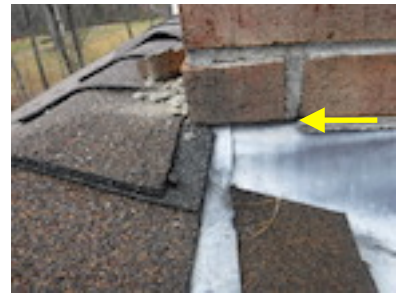
- The central heating system, an oil fired New Yorker hot water boiler with thermostat controlled forced hot water baseboard distribution, ran smoothly and responded to controls. Service logs were present indicating last service in 12/2018. Annual service by a qualified technician is recommended into the future.
- The bricks and mortar at the top of the chimney are loose, falling out and deteriorated in places. Water is likely getting between the bricks and eroding the mortar, or freezing between the bricks, causing cracking. Having the chimney repointed, including around the flashing, is recommended.

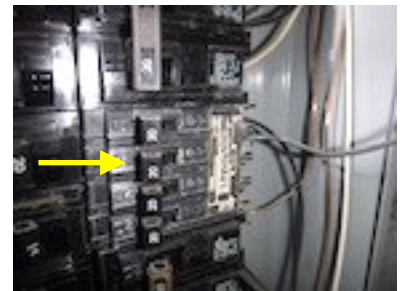
- One 20-amp breaker is oversized for the 14-gauge wire connected to it. It is possible that the wire could overheat and start a fire before the breaker trips. Replacing the breaker with a 15 amp breaker is recommended.

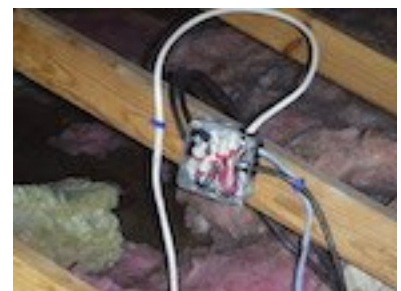
- Open junction boxes were found in the attic and the basement. Covering electrical junctions protects people from accidental shock and can prevent a fire from spreading if the wires arc. Adding junction boxes where needed is recommended.

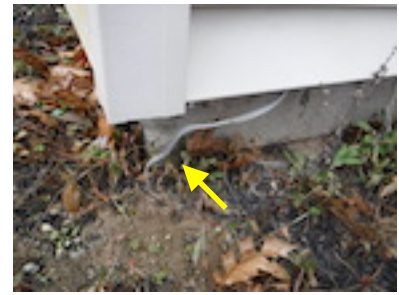
- Adding a protective conduit to the exterior electrical wire connecting the house to the driveway lamp post is recommended to prevent the wire from being damaged or becoming disconnected.

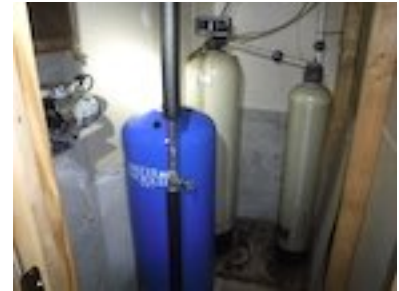
- A water treatment system is installed. Contacting the provider is recommended to determine its purpose and whether any service is required. Try to locate the Owner's Manual for operation and service instructions.

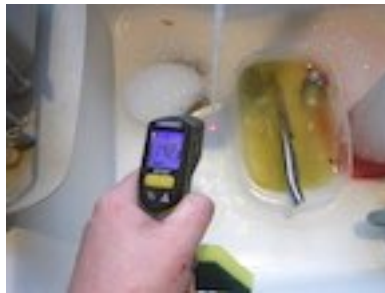
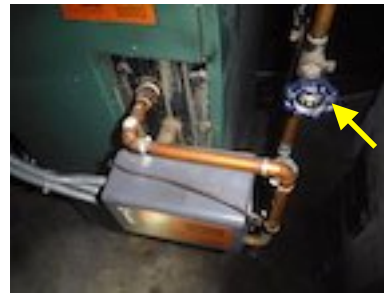
- The domestic hot water in the bathroom sink reached 143° Fahrenheit, which could cause injury and scalding. 120° Fahrenheit is considered the maximum safe hot water temperature. The water temperature can be controlled on the heating coil on the hot water boiler in the basement.

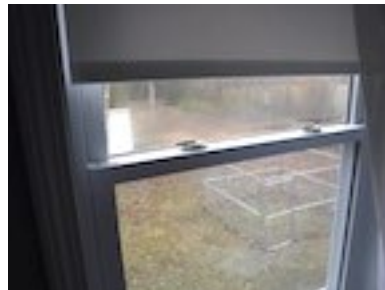
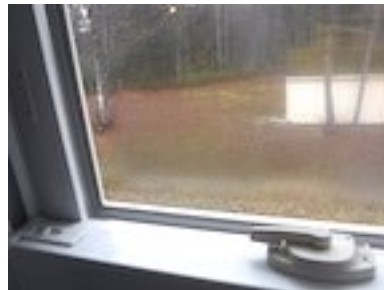
- The seal has failed at a window in the middle bedroom, causing condensation between the panes. This condition will continue to worsen; glass replacement is the only practical remedy.

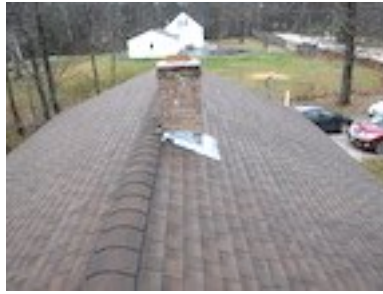
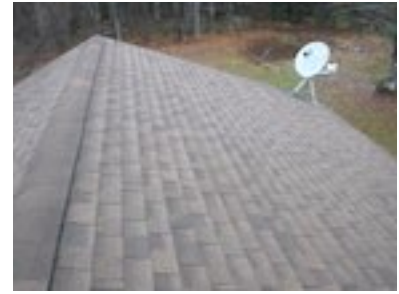
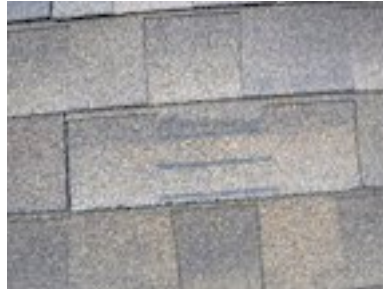
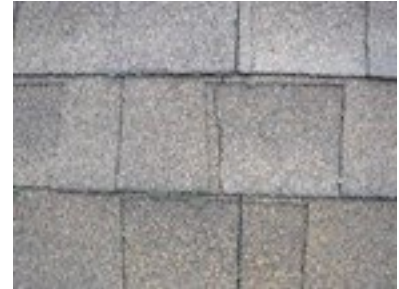
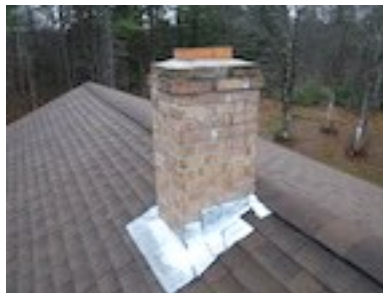
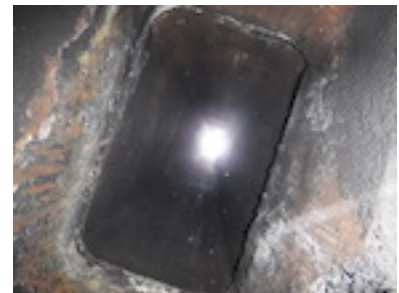
- Roof shingles are reportedly 16 years old and in generally fair condition with possibly 7 years of service life remaining. No problems or evidence of leaking was observed. This type of shingle has an expected service life of 25-30 years.

- Several shingles are cracked. Shingle tabs are missing in places. Repairing or replacing these shingles are recommended.
- Covering exposed fasteners with roofing caulk or sealant is recommended to prevent water from leaking through the nail holes.

- The interior of the chimney flue was clear and unobstructed. A comprehensive interior inspection is beyond the scope of this report. The bricks and mortar at the top of the chimney are loose, falling out and deteriorated in places. Water is likely getting between the bricks and eroding the mortar, or freezing and cracking between the bricks. Having the chimney repointed is recommended.

- Some discoloration of the roof sheathing in the attic can indicate that water has been getting behind the flashing above the chimney. Repointing the bricks and fully evaluating the flashing in this area is recommended.

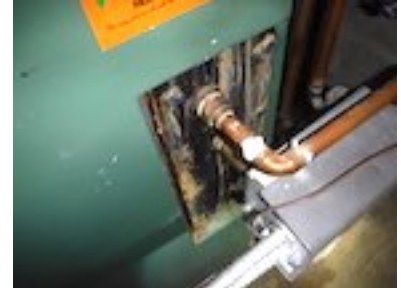
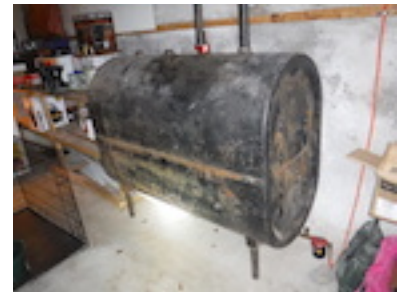
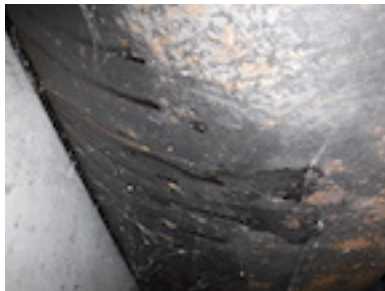
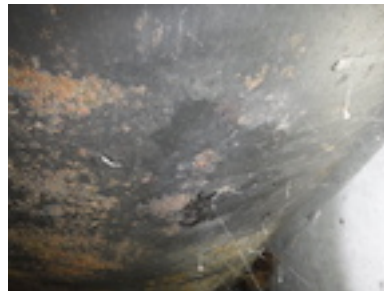
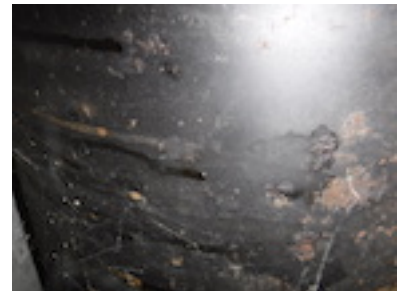
- The central heating system ran smoothly and responded to controls. Service logs were present indicating last service in 12/2018 with an efficiency of 82%, which is high. Annual service by a qualified technician is recommended into the future.

- Some evidence of past leaking was observed on the domestic hot water heating coil cover on the boiler. Having this area examined during annual service is recommended.

- A 275-gallon oil tank is installed in the basement. The fuel line is sleeved, as is required by current codes. The main fuel shutoff is located near the fuel filter. The tank shows signs of rust under the tank. Having this tank further evaluated by a qualified professional is recommended. If the tank is leaking, it should be replaced before it fails and leaks a significant amount of oil. In the photos below, it appears that the oil may be dripping from the fill pipes, down the back of the tank, and may not be from bottom rusting.

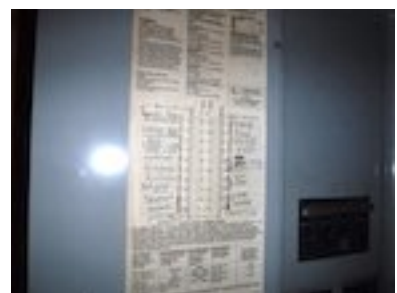
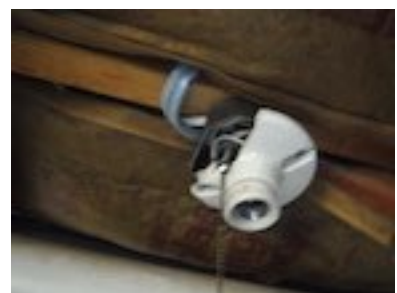
- A light covering in the basement is broken, exposing wiring. Repairing or replacing this light cover is recommended.

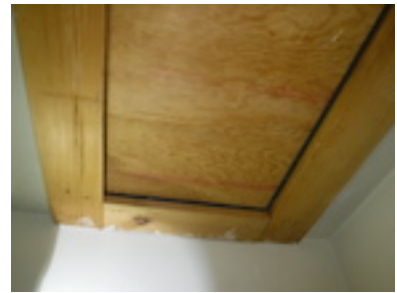
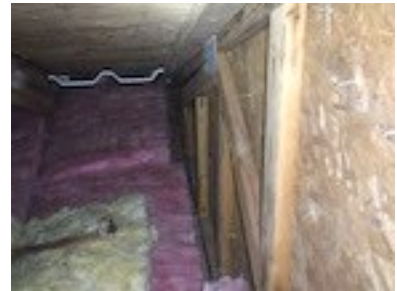
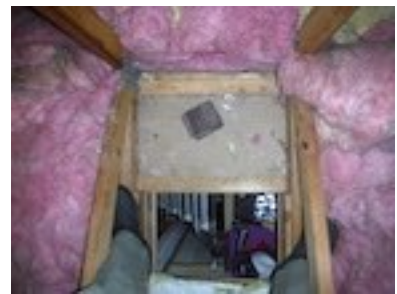
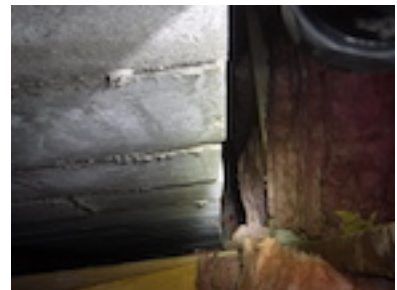
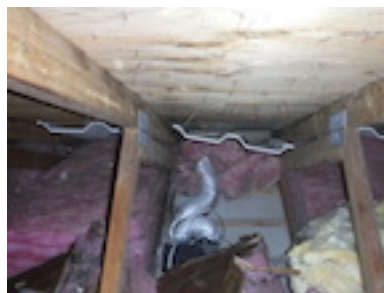
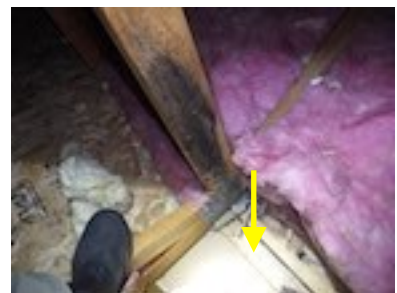
- Attic insulation levels may meet the standards for a house of this age, but would be considered low by today's standards. There are some areas in the attic with little or no insulation. Adding additional insulation is recommended.

- The paper facing on fiberglass insulation batts in the basement is exposed, and is flammable. The manufacturer's printed notice on the paper facing states that it needs to be covered.

- Adding insulation above the bathroom vent duct is recommended to prevent moisture from condensing and pooling in the duct, or dripping back into the bathroom.

- No signs of condensation problems were observed on the roof sheathing in the attic.
- There is no air barrier around the chimney chase into the attic. A considerable amount of warm air may be lost around this chase. Sealing the gap in the attic is recommended.

- Sealing all of the holes for lights and wiring into the attic would prevent additional heat loss and moisture from getting into the attic. In one area, evidence of significant heat and moisture was observed above wire holes.

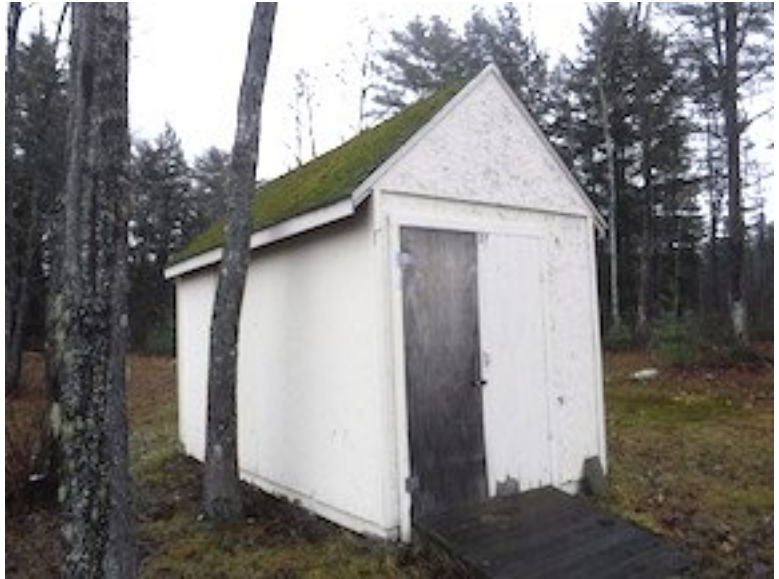
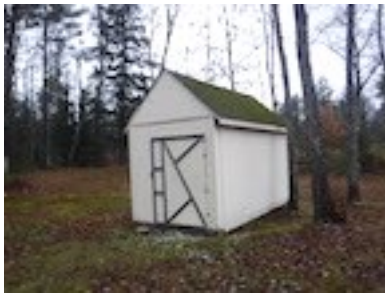
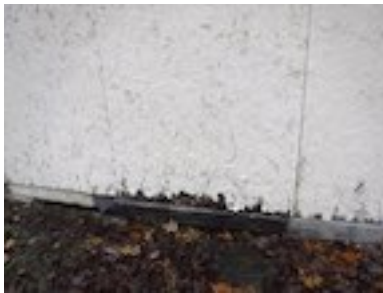
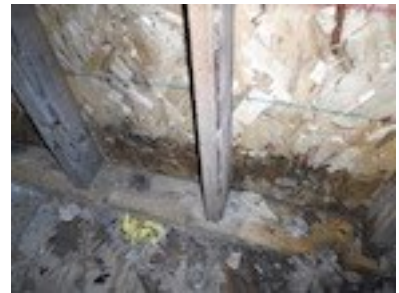
A wood framed shed on concrete blocks. The sheathing of the shed is not meant for long term exposure to the weather, and has begun to flake apart. Water running off the roof and splashing back against the siding has caused deterioration around the base of the shed. Raising the shed on blocks could help to prolong the life of the structure.
