# BUILDING INSPECTION REPORT

## (ADDRESS)

**Inspection Date:**  
Wednesday, July 31, 2019

**Prepared by:**  
Ray Mayo  
Mayo Home Inspections, LLC  
ASHI Certified Inspector #261817  
P.O. Box 841  
Brunswick, ME 04011  
(207) 522-9938

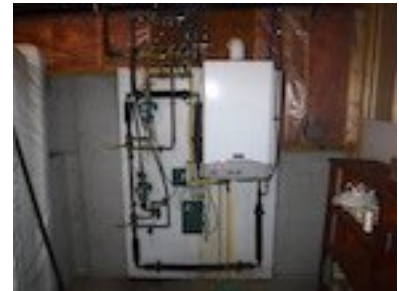
- The central heating system, a propane fired, wall mounted, on demand hot water boiler, likely a BAXI brand, with thermostat controlled forced hot water radiator and radiant floor distribution, ran smoothly and responded to controls. No service logs were found during the inspection. Recent service is reported. Annual service by a qualified technician is recommended if not done so in the last year.

- This boiler creates condensate, a corrosive liquid, as a byproduct of combustion. There was no visible neutralizer installed, which is required. Having this boiler further evaluated by a qualified professional is recommended.

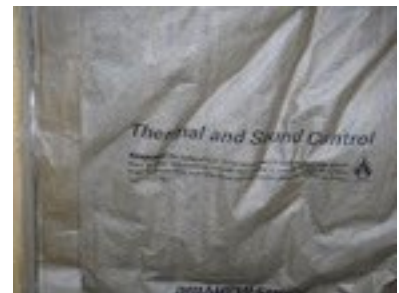
- The paper facing on fiberglass insulation batts in the basement ceiling is exposed, and is flammable. The manufacturer's printed notice on the paper facing states that it needs to be covered.

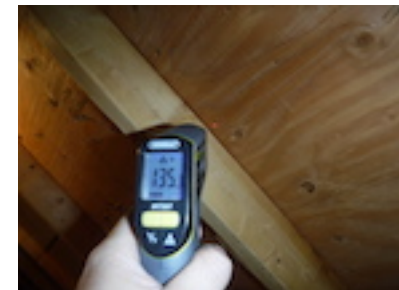
- The attic was very hot. Current building practices recommend that there is no more than a 20° Fahrenheit difference between attic temperatures and exterior temperatures. Large differences in temperature can deteriorate shingles and cause additional problems for houses. Adjusting the ventilation may help to encourage airflow through the vents.

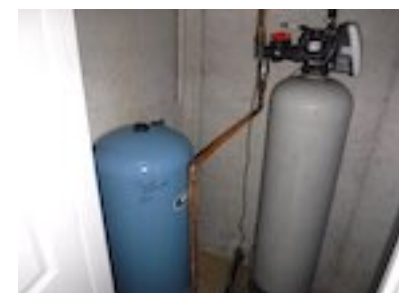
- A water treatment system is installed but its purpose is unclear. Refer to the Owner's Manual for operation and service instructions. Obtaining the Installer's name is also recommended.

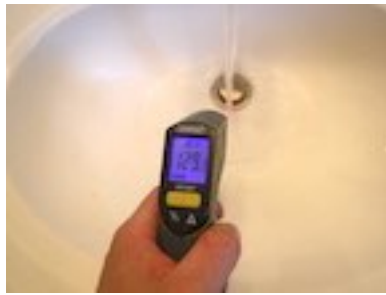
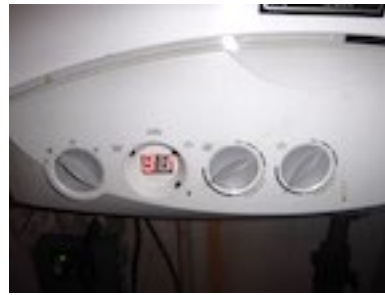
- The domestic hot water in the bathroom sink reached 129° Fahrenheit, which could cause injury and scalding. 120° Fahrenheit is considered the maximum safe hot water temperature. The water temperature can be controlled on the hot water boiler in the basement.

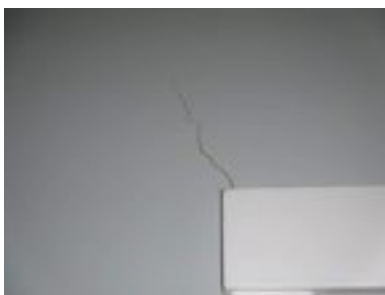
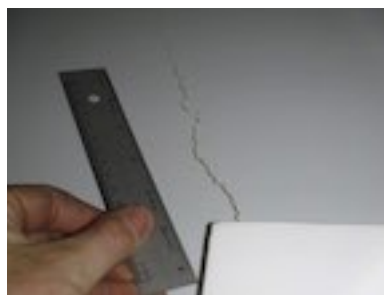
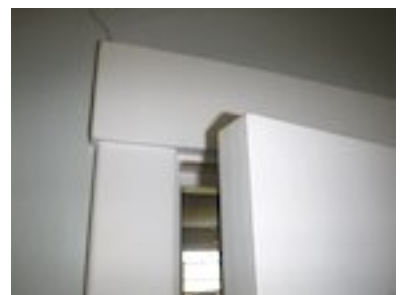
- The drywall has cracked above the master bedroom door, and the door does not shut fully. It is possible that the house has settled slightly in this area. There were no other indications of settling in the house. Adjusting the door, repairing the drywall and monitoring this area for further movement is recommended.

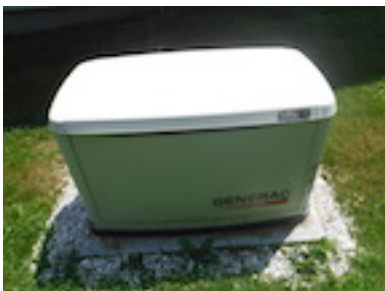
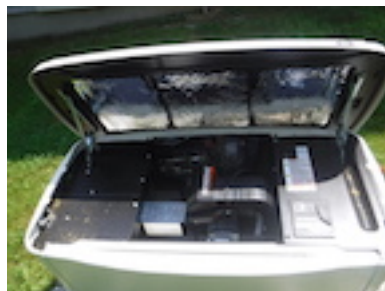
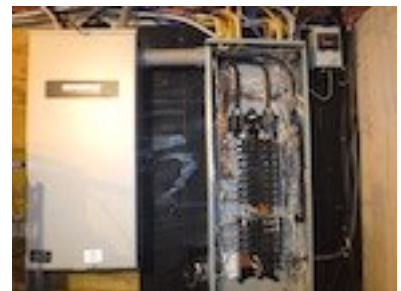
- A propane-fired fully automatic Generac generator is installed behind the house. The generator started automatically when the power was shut off at the generator panel. Refer to the owner's manual for operating and service instructions.

- Adding a protective conduit to the exposed electrical wire at the base of the light post by the garage is recommended to prevent the wire from being damaged or becoming disconnected.

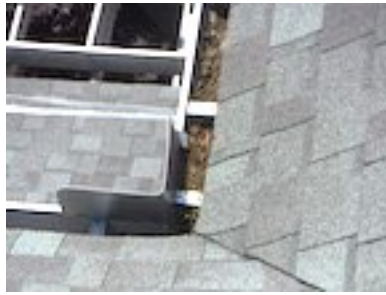
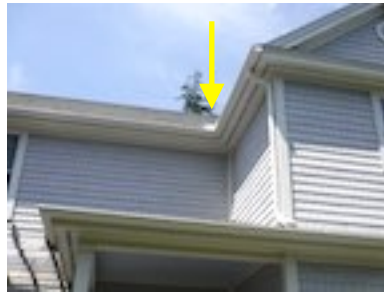
- The gutters around the house are mostly clear, but there is a clog with plants growing in it on the southeast side. Overflowing gutters can deteriorate the house trim. Cleaning the gutters regularly is recommended.
