BUILDING INSPECTION REPORT

Inspection Date:
Wednesday, October 30, 2019

Prepared by:
Ray Mayo
ASHI Certified Inspector #261817
Mayo Home Inspections, LLC
P.O. Box 841
Brunswick, ME 04011
(207) 522-9938

The inspected property consists of an approximately 140 year old 2-story wood framed Colonial style house with an attached garage. The house is serviced by a private water supply and a private septic system and is considered to face South.

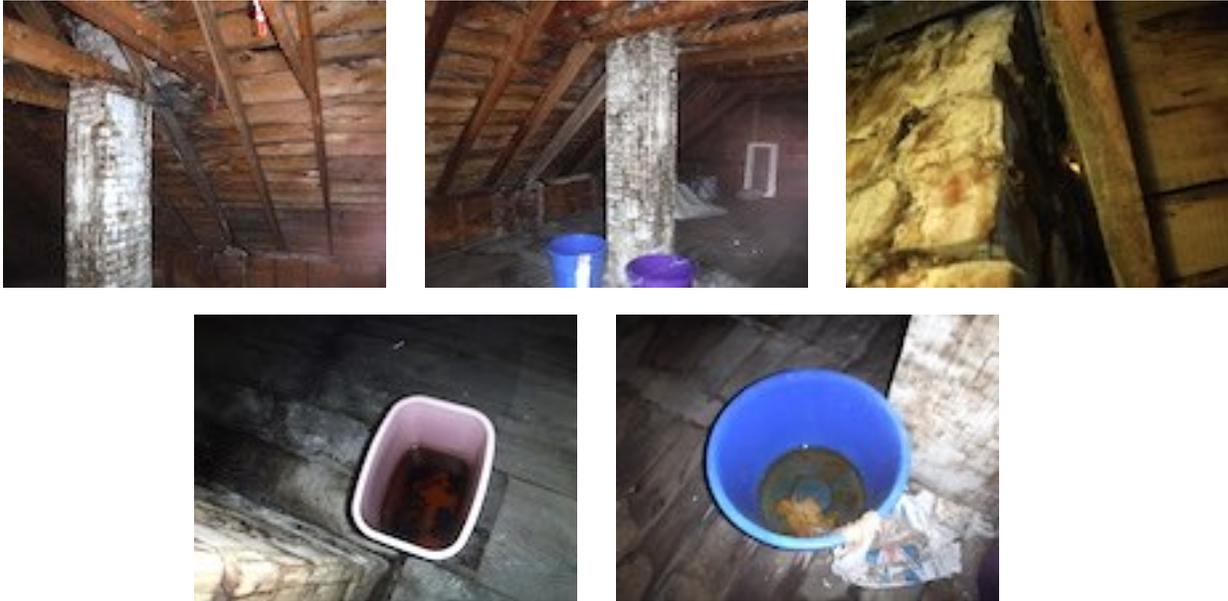
- There is evidence that the chimney flashing on both chimneys is leaking. There were buckets under the chimneys in the attic with significant amounts of water in them. Having a professional roofer or mason reevaluate the chimney flashing is recommended.

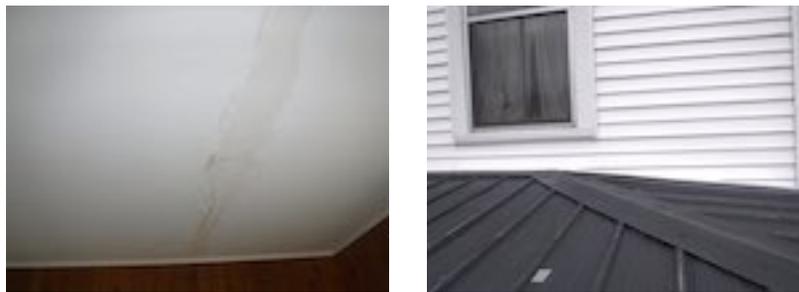
- Evidence of a water leak was found on the ceiling in the downstairs office. It is not clear if the source of the water is the bathroom above this room or a problem with the porch roof flashing. It is also not clear if the leak is current, or has since been fixed. Further investigation and monitoring of this area and is recommended.

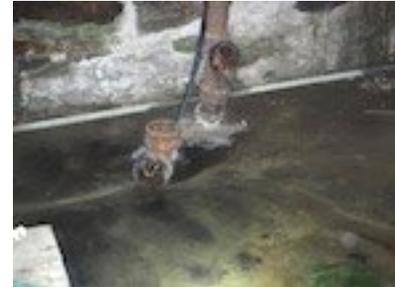
- Moisture enters the basement periodically and there was some standing water in the basement. The basement is designed to Chanel moisture to a foundation drain, but reducing or preventing moisture from getting into the foundation in the first place is the best course of action, either by regrading the land to shed water away from the house, and/or adding gutters (especially on the south side of the house). Controlling moisture created in the basement by draining the hot water heater and the water softener directly into the foundation drain and running a dehumidifier after fixing all other sources of moisture is also recommended. There is also evidence of moisture running down the north chimney, and adding a cover to divert rain would prevent this moisture from ending up in the basement.

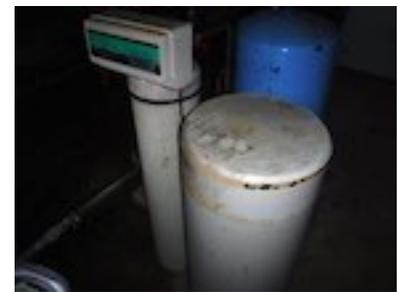
- A water treatment system is installed. Contacting the provider is recommended to determine its purpose and whether any service is required. Refer to the Owner's Manual for operation and service instructions.

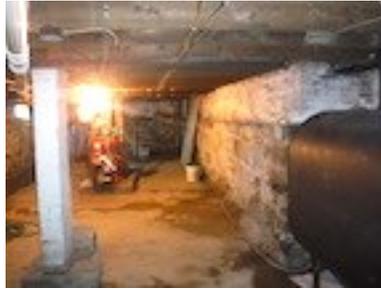
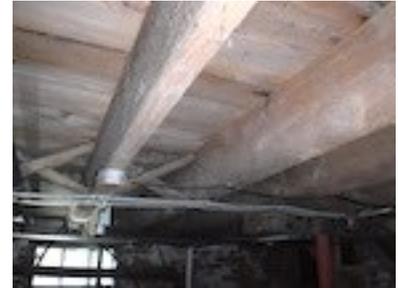
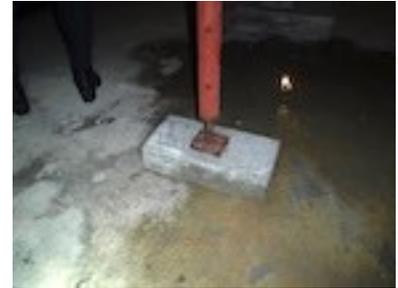
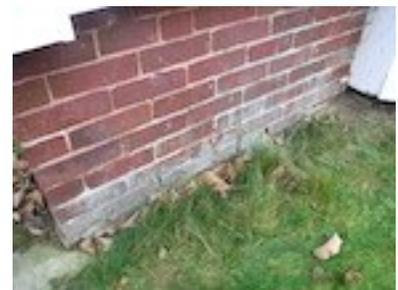
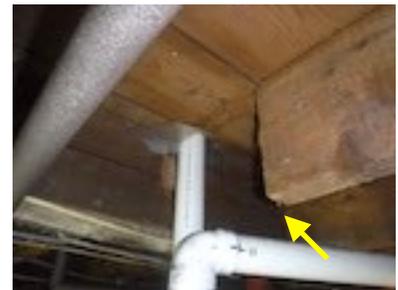
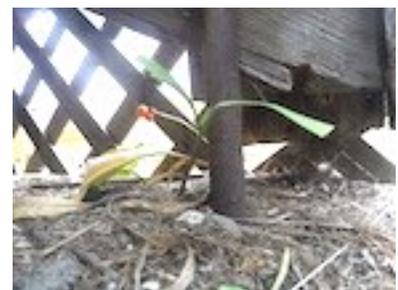
- No immediate, significant structural problems were observed.
- Several temporary, adjustable metal jack posts were found in the basement. These posts should be replaced with permanent, load bearing metal or wood columns.

- Repointing the bricks around the foundation exterior is recommended to prevent moisture, insects and rodents from getting into the basement. This type of mortar deterioration is most likely caused from water running off of the roof and splashing back against the foundation. Adding gutters could prevent future deterioration.

- Cutting through floor joists is generally not recommended because it can destabilize the structure. A joists on the southeast end of the basement has been cut through to install plumbing fixtures. This joist should have appropriate reinforcement added.

- The front porch and the office are installed on metal posts driven into the ground. This installation is common for houses of this age, and there were no indications of settling or problems. It is just surprising that such a small post does not rust and can support so much weight.

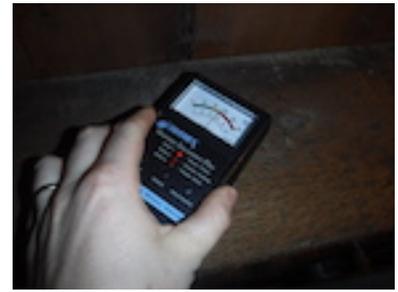
- Moisture enters the basement periodically and there was some standing water in the basement. The basement is designed to Chanel moisture to a foundation drain, but reducing or preventing moisture from getting into the foundation in the first place is the best course of action, either by regrading the land to shed water away from the house, and/or adding gutters (especially on the south side of the house). Controlling moisture created in the basement by draining the hot water heater and the water softener directly into the foundation drain and running a dehumidifier after fixing all other sources of moisture is also recommended. There is also evidence of moisture running down the north chimney, and adding a cover to divert rain would prevent this moisture from ending up in the basement.

- Basement moisture has caused significant mold growth in the basement. This growth has trapped moisture and completely deteriorated an interior wall in the basement, likely meant for a root cellar. Floor joists and subflooring throughout the basement tested high for moisture, but no significant structural problems were observed. The deteriorated boards and mold should be removed, and further work should be done in the basement to address the moisture problems.

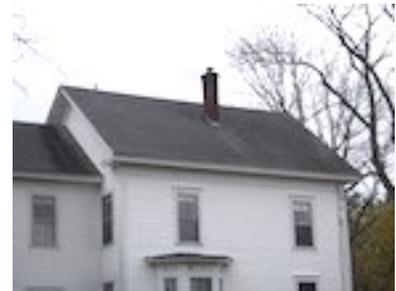
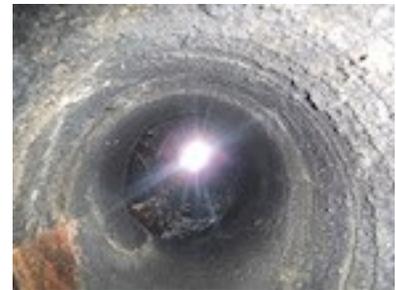
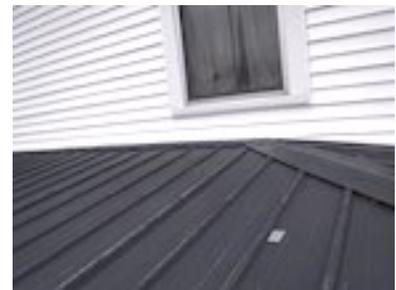
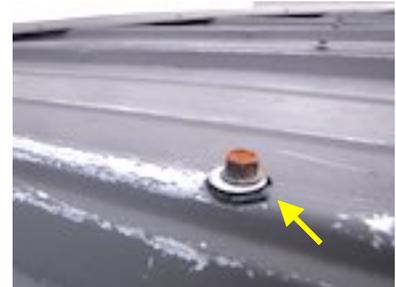
- There is evidence that the chimney flashing on both chimneys is leaking. There were buckets under the chimneys in the attic with significant amounts of water in them. Having a professional roofer or mason reevaluate the chimney flashing is recommended.

- Exposed fastener metal roofing has small rubber gaskets that prevent the fastener holes from leaking water through the roof. These rubber gaskets need to be replaced every 15-20 years because they dry out and crack. The gaskets on the porch roof show signs of cracking, and are likely due for replacement.

- Repointing the chimney bricks in the attic is recommended to prevent them from becoming loose. Having both chimneys fully evaluated by a qualified professional is recommended.

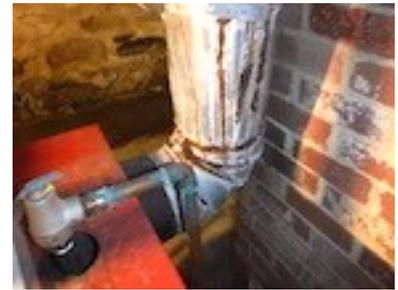
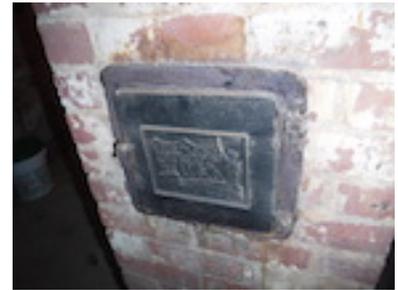
- There is evidence of moisture running down the north chimney, causing rust at the boiler exhaust pipe and at the chimney cleanout door. Adding a cover to divert rain would prevent this moisture from ending up in the basement.

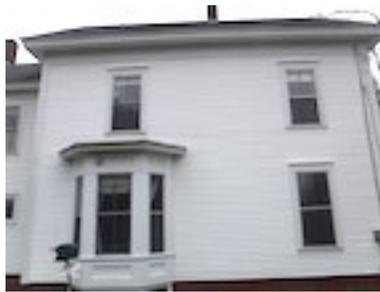
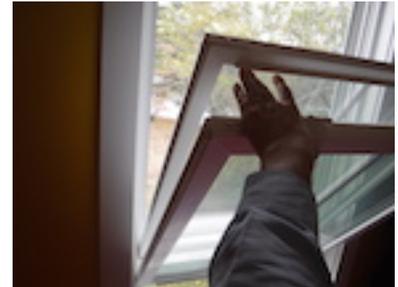
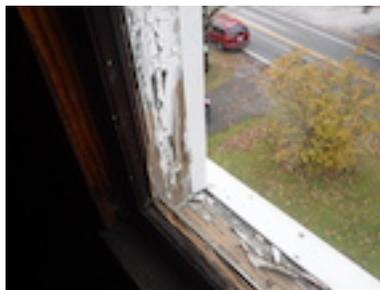
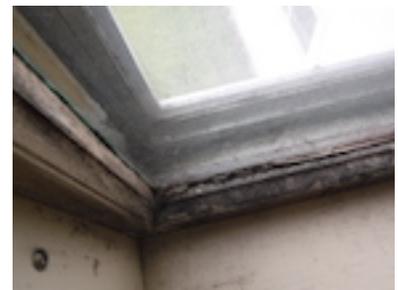
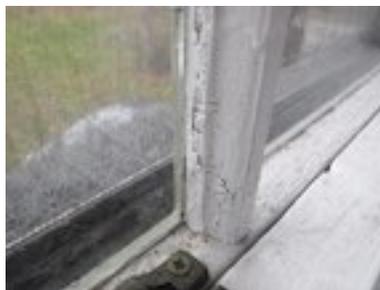
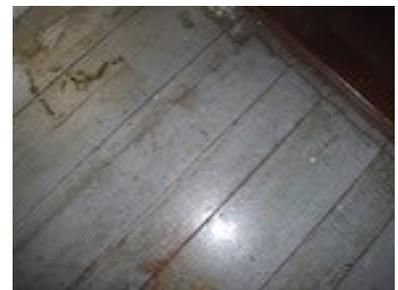
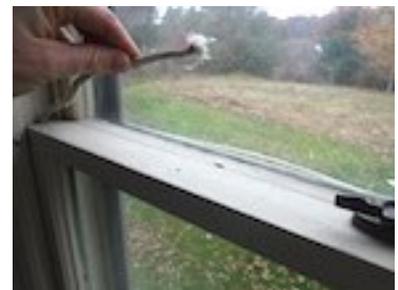
- The siding is in very good condition. No significant damage or defects were found during the inspection.
- Metal trim is missing on the north side of the main house roof, above the garage door, and in many places around the garage exterior.

- The wood trim on the house is due for repainting in many places.
- Based on the age of the house, lead paint is likely present on interior and exterior surfaces. Caution should be used when scraping and sanding to not create dust and to collect and properly dispose of paint chips.

- Window panes in the upstairs west bedroom, the dining room and two in the office are cracked.
- Older wood sash windows are due for reglazing in places.

- Two windows have disconnected sash cords. The counterweights on the sides of the windows, in the jambs, keep the window panes in place. If the sash cords break or become disconnected, the windows can slam down, causing injury or damage. Repairing or replacing damaged or missing sash cords is recommended.

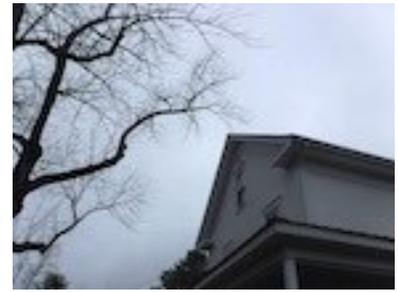
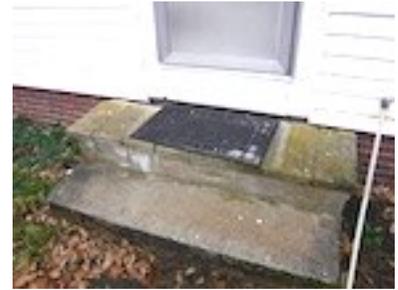
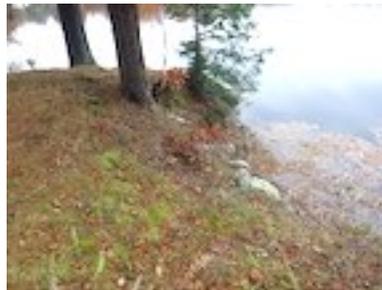
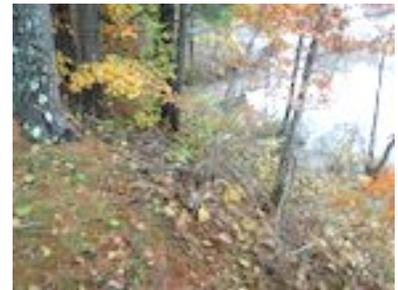
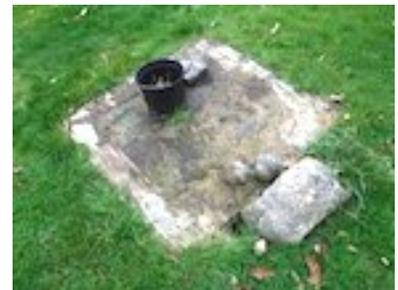
- Trees overhanging the house could cause damage if they were to fall on the house. They can also trap moisture against the house, accelerating deterioration. Watch for signs of decay and consider cutting these trees back.

- There are some areas around the foundation where the ground dips and may trap moisture against the building, or channel moisture into the basement. Regrading in these places is recommended, to shed water away from the building. Several low spots had collected a fair bit of standing water.

- The steps up into the east door are very high and could be a tripping hazard.
- Evaluation of erosion potential along the shore is beyond the scope of this report.

- The basement bulkhead concrete foundation is cracked and falling apart. Gaps in the bulkhead door could allow insects and rodents into the house.
- A hole in the ground on the east side of the garage has a securely fastened wooden cover. It is not clear what is under this cover, but it could possibly be an open well.

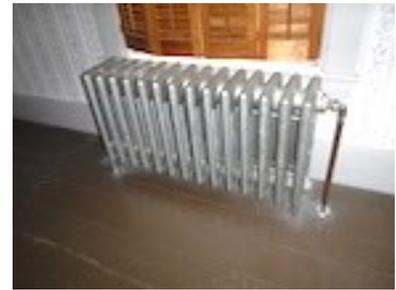
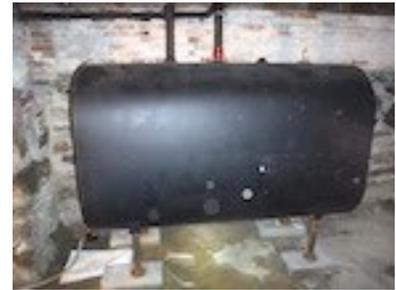
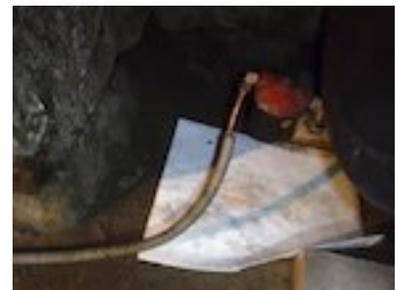
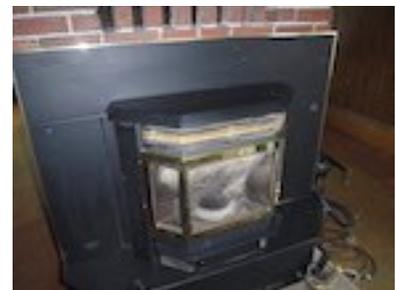
- The central heating system ran smoothly and responded to controls. Service logs were present indicating last service on 8/21/2019 with an efficiency of 82%, which is high. Annual service by a qualified technician is recommended into the future.

- A temperature/ pressure safety relief valve downpipe on the boiler has some water leaking from it. Having this further evaluated by a qualified heating professional is recommended, because it could be an indication of a serious problem with the boiler.

- A 330-gallon oil tank is installed in the basement. The fuel line is sleeved, as is required by current codes. The main fuel shutoff is located near the fuel filter. Some rust on the bottom of the tank could be an indication of interior deterioration, and should be further evaluated by a heating professional.

- A pellet stove fireplace insert is installed in the dining room. The stove was not plugged in, and was not tested. No obvious damage or defects were observed. This stove should be hardwired, because an extension cord could be a tripping hazard. Having this stove running at final walkthrough is recommended.

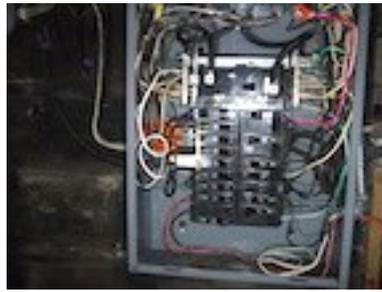
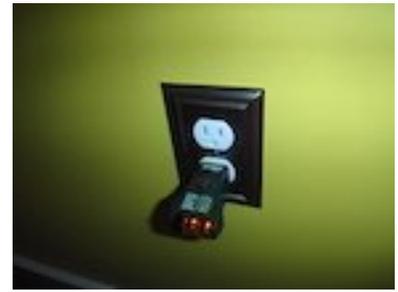
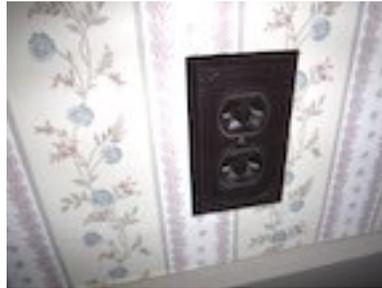
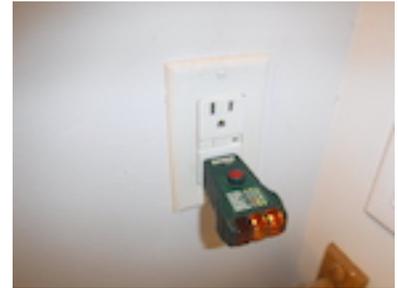
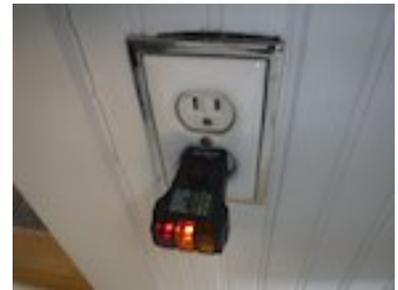
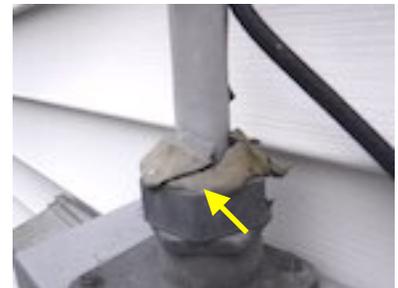
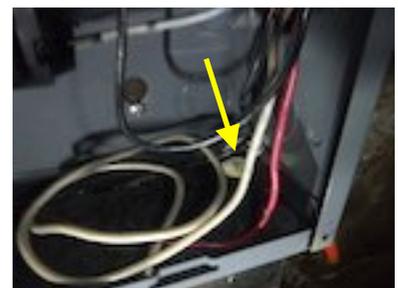
- A representative number of outlets and switches were operated during the inspection. An electrical outlet in the second floor bathroom is wired Hot/Neutral Reverse and should be rewired correctly. Replacing the kitchen electrical outlets with GFI protected outlets is recommended. The downstairs bathroom GFI outlet does not trip and should be replaced.

- Recaulking where the main service wire enters the electrical meter would prevent water from getting into the meter.
- Adding a protective conduit to the ground wire connecting the electrical meter to the grounding rod is recommended, to prevent the wire from being damaged or becoming disconnected.

- The main distribution panel cover was removed to inspect the interior. No electrical problems were observed.
- Sealing the hole at the bottom of the main distribution panel is recommended to prevent rodent intrusion and to ensure a fireproof enclosure.

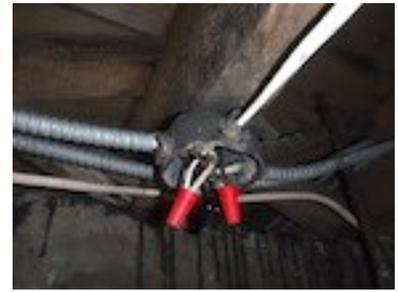
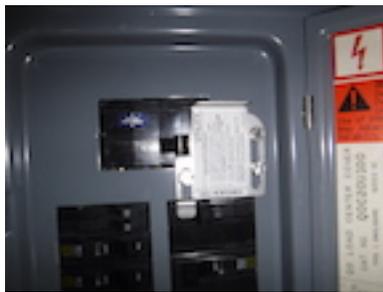
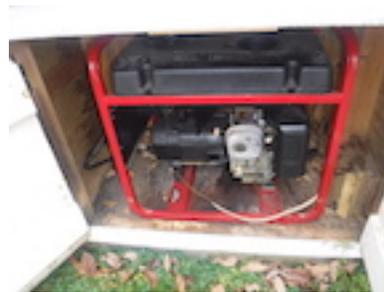
- An uncovered junction box was found in the basement. Covering electrical junctions protects people from accidental shock and can prevent a fire from spreading if the wires arc. Adding cover plates where needed is recommended.
- A photovoltaic system is installed, with two ground-mounted PV panels and an inverter installed in the garage. Refer to the Owner's Manual for operation and service instructions. Obtaining the Installer's name is also recommended.
- The main distribution panel is wired for an electric generator, with proper safety features in place to prevent back-feeding onto the electric grid. The generator outlet is located near the back door to the house.

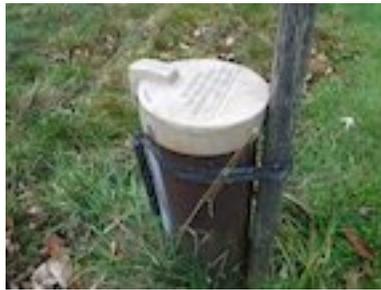
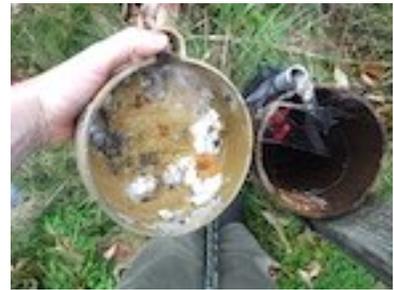
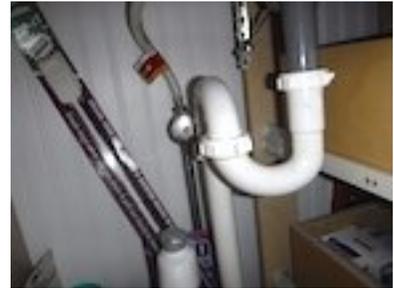
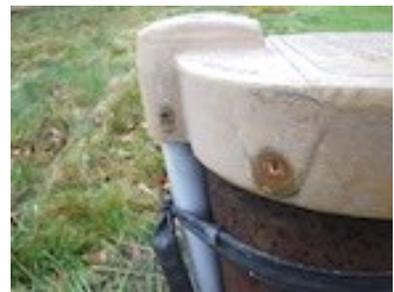
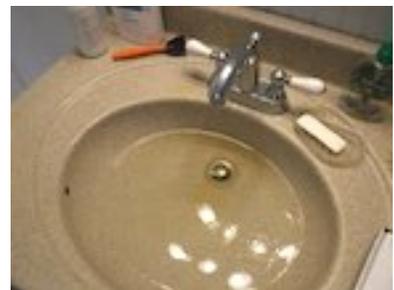
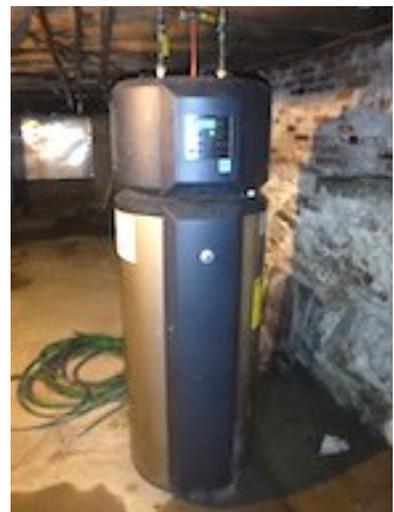
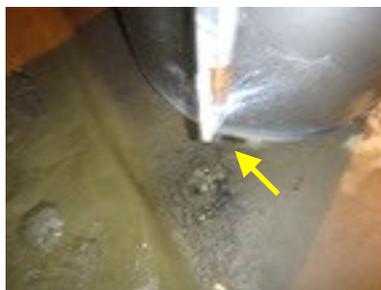
- The bolts on the well cover have rusted off, and the cover is loose. Replacing this well cover with a sanitary well cover is recommended.
- The main water shutoff is adjacent to the well pressure tank.
- A water treatment system is installed. Contacting the provider is recommended to determine its purpose and whether any service is required. Refer to the Owner's Manual for operation and service instructions.
- Water supply and drainage worked well in the downstairs bathroom and the kitchen. The upstairs bathroom sink has a very slow drain, and may need to be cleaned.
- The septic system was not inspected.
- The electric hot water heater in the basement also acts as a dehumidifier. The drain pipe for this heater drains right next to it. Having this drain pipe terminate at the basement drain is recommended.

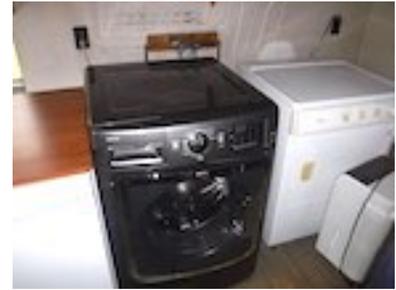
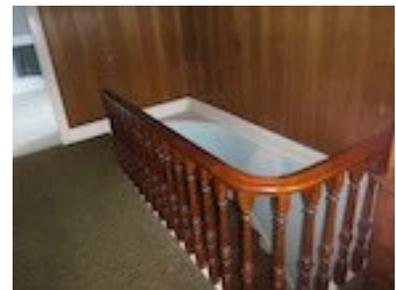
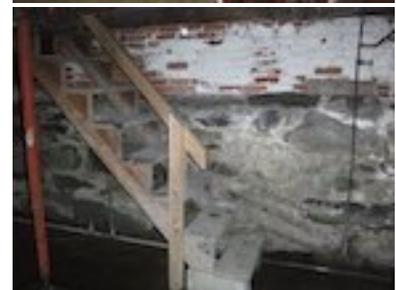
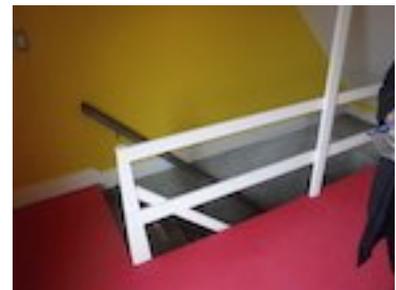
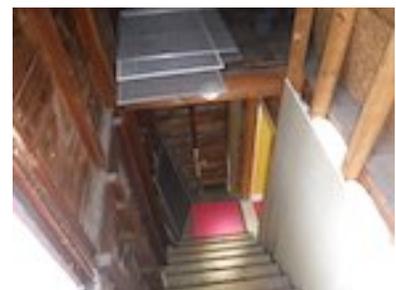
- The stove is very old, very dirty, and was not tested. The refrigerator was functional.
- Most interior surfaces including walls, ceilings, and floors are in generally good condition with cosmetic repairs needed in areas.

- Evidence of a water leak was found on the ceiling in the downstairs office. It is not clear if the source of the water is the bathroom above this room or a problem with the porch roof flashing. It is also not clear if the leak is current, or has since been fixed. Further investigation and monitoring of this area and is recommended.

- The front, rear, basement and attic stairs could be fall hazards with low guard rails, large gaps in the guard rails, and no handrail on the attic stairs. Adding handrails and guard rails, where appropriate, would greatly reduce the chance of injury in these locations.

- Laundry appliances were operational. The dryer is propane fired, and a dryer vent to the exterior is installed as recommended.
- Battery powered smoke detectors are installed in the upstairs hallway, the north bedroom and the dining room only. Adding smoke detectors to all bedrooms is recommended, as is replacing all smoke detectors over 10 years old. No carbon monoxide detectors were found during the inspection.

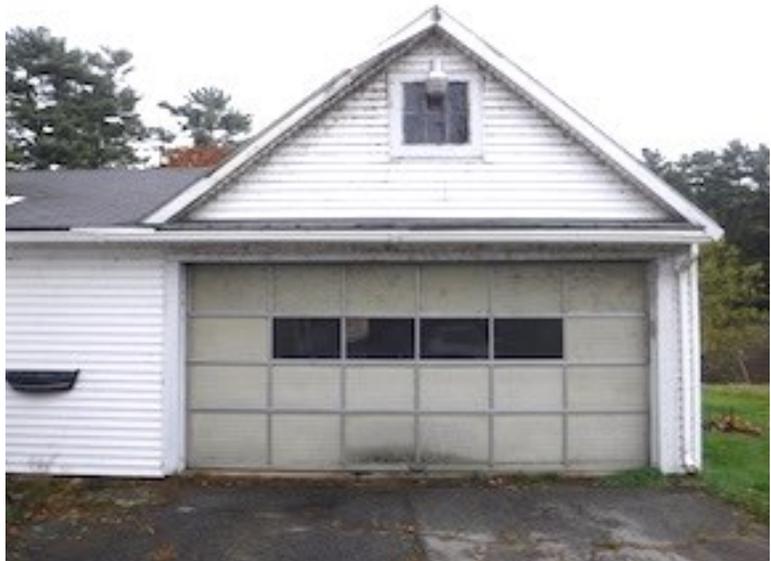
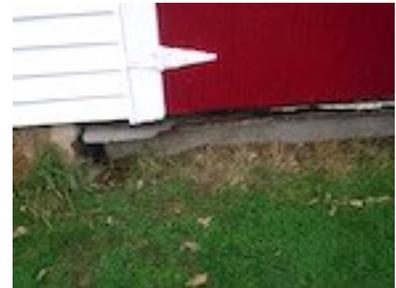
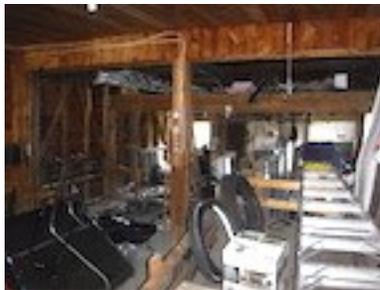
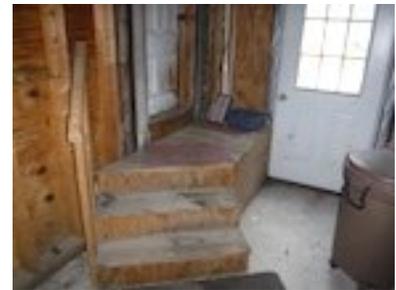
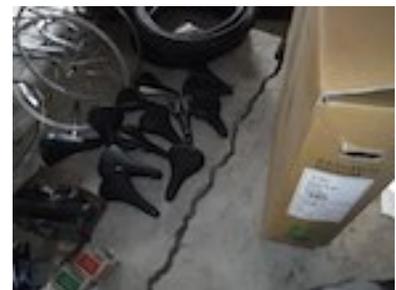
- The garage trim is missing or deteriorated in many places.
- The garage door opener was functioning as intended, with auto-reverse optical and pressure safety sensors installed and operational.
- Current codes require fire-rated walls and doors be installed between garages and living spaces. This house does not have such a fire barrier. The house is not required to have one installed due to its age, but it is recommended.
- The stairs up to the house from the garage could be a significant trip or fall hazard.
- There is evidence that several garage floors have been poured on top of each other, indicating that the garage floor has likely settled and sunk over time. Large cracks in the garage floor could indicate that the subflooring was not correctly compacted, or that water has gotten under the slab.
