BUILDING INSPECTION REPORT

(ADDRESS)

Tuesday, November 19, 2019

Mayo Home Inspections, LLC

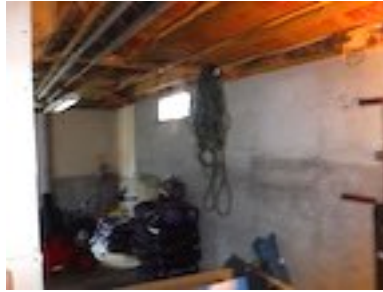
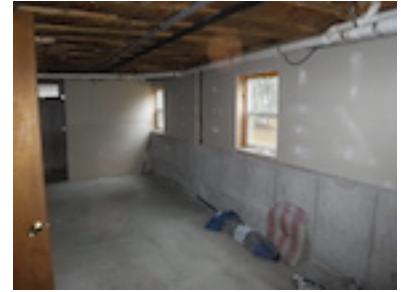
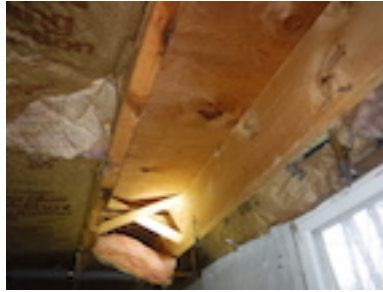
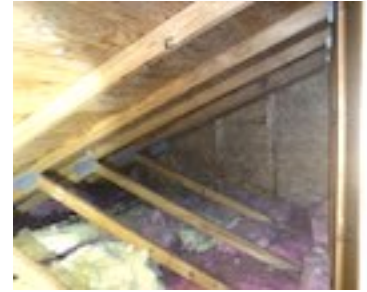
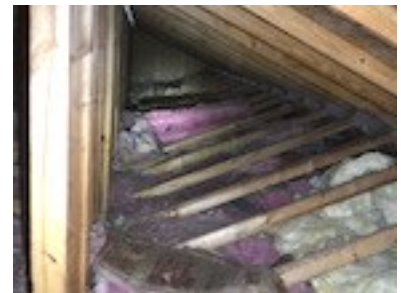
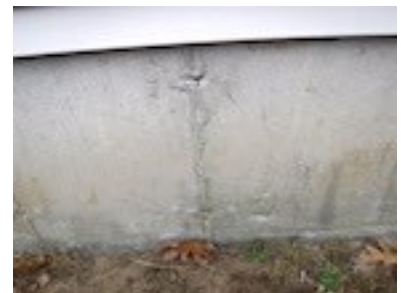
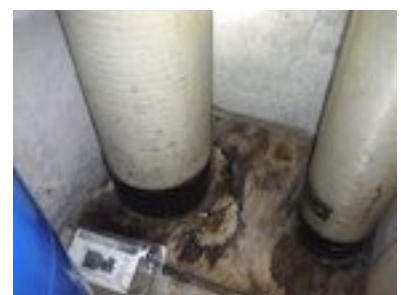
- No significant structural problems were observed.
- Small cracks in the foundation should be patched and monitored for further separation and for water intrusion.

- There were no indications of significant moisture problems in the basement.
- A perimeter drain access is likely present under the water treatment system in a basement closet. The drain cleanout was not accessible to determine if there were any evidence of water in the drain system. The plywood board supporting the water treatment system is deteriorated, and should be replaced. It is not clear if the water filtration tanks are supported in any additional way.

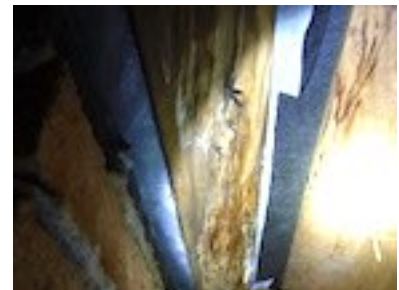
- Several shingles are cracked. Shingle tabs are missing in places. Repairing or replacing these shingles are recommended.
- Covering exposed fasteners with roofing caulk or sealant is recommended to prevent water from leaking through the nail holes.

- The interior of the chimney flue was clear and unobstructed. A comprehensive interior inspection is beyond the scope of this report. The bricks and mortar at the top of the chimney are loose, falling out and deteriorated in places. Water is likely getting between the bricks and eroding the mortar, or freezing and cracking between the bricks. Having the chimney repointed is recommended.

- Some discoloration of the roof sheathing in the attic can indicate that water has been getting behind the flashing above the chimney. Repointing the bricks and fully evaluating the flashing in this area is recommended.

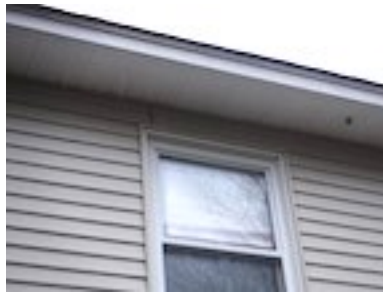
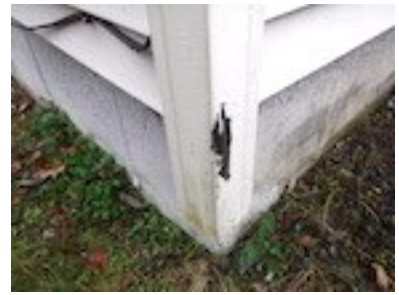
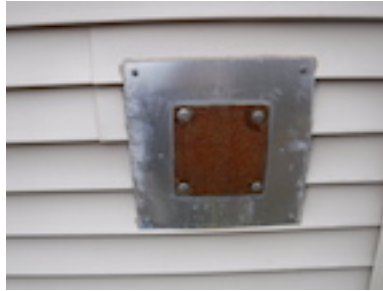
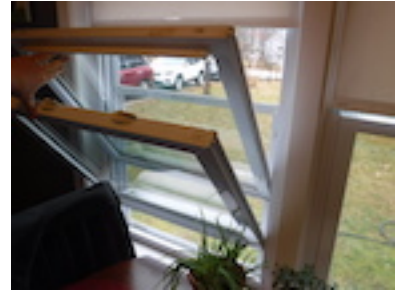
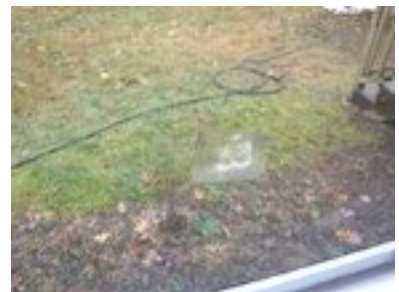
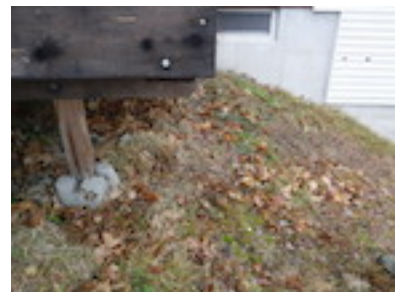
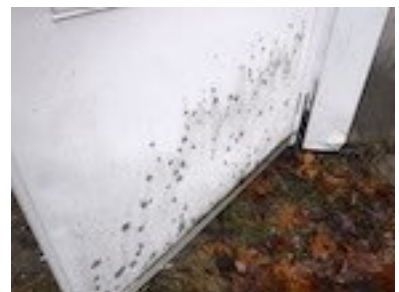
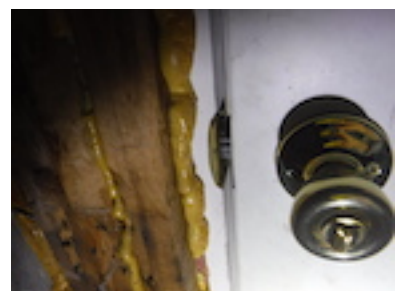
- The siding is in generally good condition. No significant damage or defects were found during the inspection.
- Some small damaged sections and cracks in the siding should be monitored for water intrusion and patched or repaired as needed.

- A representative number of doors and windows were inspected. The presence of screens for all windows was not verified. Several window screens in the dining room are ripped and have been repaired with tape.

- The basement storm door has absorbed water and expanded, and should be replaced.
- The seal has failed at a window in the middle bedroom, causing condensation between the panes. This condition will continue to worsen; glass replacement is the only practical remedy.

- Exterior walkways and vegetation are in good condition.
- The basement exterior door does not securely latch, and may need to be adjusted. The door cannot lock if it does not latch.

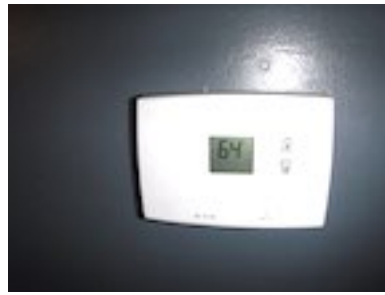
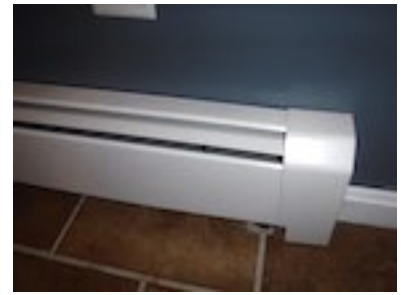
- The central heating system ran smoothly and responded to controls. Service logs were present indicating last service in 12/2018 with an efficiency of 82%, which is high. Annual service by a qualified technician is recommended into the future.

- Some evidence of past leaking was observed on the domestic hot water heating coil cover on the boiler. Having this area examined during annual service is recommended.

- A 275-gallon oil tank is installed in the basement. The fuel line is sleeved, as is required by current codes. The main fuel shutoff is located near the fuel filter. The tank shows signs of rust under the tank. Having this tank further evaluated by a qualified professional is recommended. If the tank is leaking, it should be replaced before it fails and leaks a significant amount of oil. In the photos below, it appears that the oil may be dripping from the fill pipes, down the back of the tank, and may not be from bottom rusting.

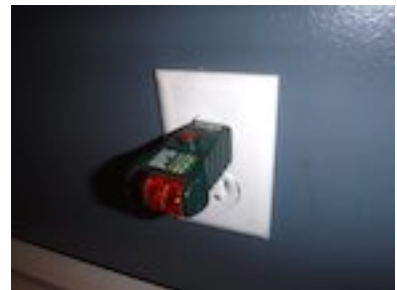
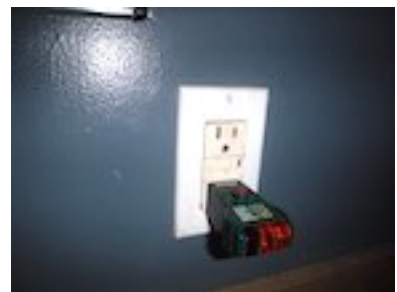
- A representative number of outlets and switches were operated during the inspection. No electrical problems were discovered.
- The main distribution panel cover was removed to inspect the interior. One 20-amp breaker is oversized for the 14-gauge wire connected to it. It is possible that the wire could overheat and start a fire before the breaker trips. Replacing the breaker with a 15 amp breaker is recommended.

- The main distribution panel directory is outdated and no longer accurate.
- Open junction boxes were found in the attic and the basement. Covering electrical junctions protects people from accidental shock and can prevent a fire from spreading if the wires arc. Adding junction boxes where needed is recommended.

- Adding a protective conduit to the exterior electrical wire connecting the house to the driveway lamp post is recommended to prevent the wire from being damaged or becoming disconnected.

- A light covering in the basement is broken, exposing wiring. Repairing or replacing this light cover is recommended.

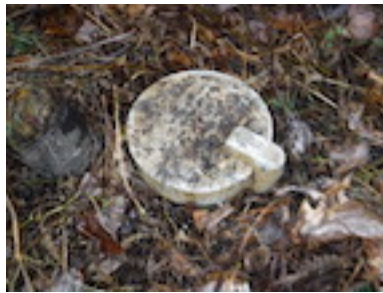
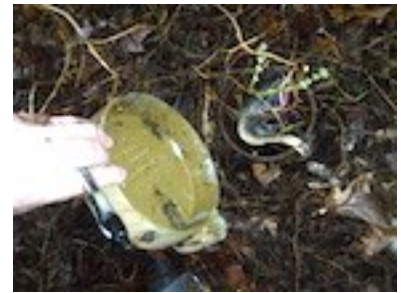
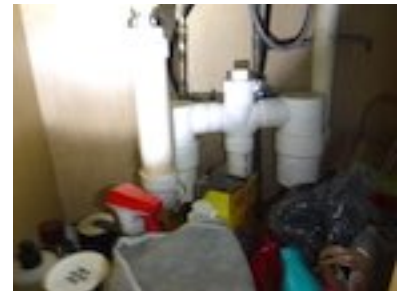
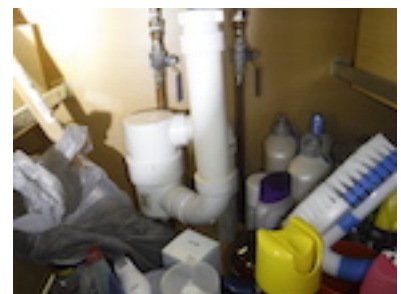
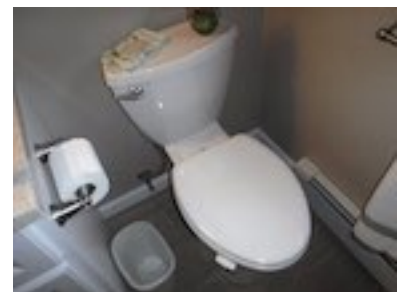
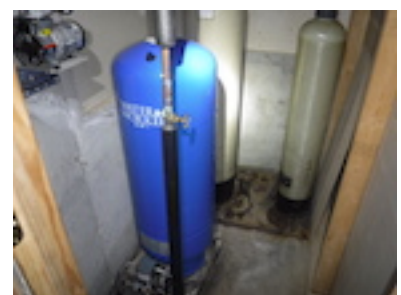
- Well covers less than 12" above the ground could possibly be contaminated from groundwater. The well cover is also loose, which can sometimes cause contaminants to get into the water. However, the water results had no indications of any problems.

- The main water shutoff is adjacent to the well pressure tank.
- A water treatment system is installed. Contacting the provider is recommended to determine its purpose and whether any service is required. Try to locate the Owner's Manual for operation and service instructions.

- Water supply and drainage worked well in all bathrooms and the kitchen.
- The toilet in the bathroom is loose, which could cause leaking beneath it. Tightening down the toilet could preserve the seal of the wax ring.

- The domestic hot water in the bathroom sink reached 143° Fahrenheit, which could cause injury and scalding. 120° Fahrenheit is considered the maximum safe hot water temperature. The water temperature can be controlled on the heating coil on the hot water boiler in the basement.

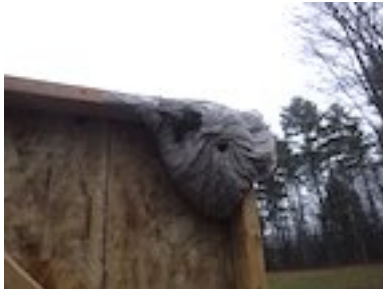
A wood framed shed on concrete blocks. The sheathing of the shed is not meant for long term exposure to the weather, and has begun to flake apart. Water running off the roof and splashing back against the siding has caused deterioration around the base of the shed. Raising the shed on blocks could help to prolong the life of the structure.
