# BUILDING INSPECTION REPORT

## (ADDRESS)

**Inspection Date:**  
Wednesday, July 31, 2019

**Prepared by:**  
Ray Mayo  
Mayo Home Inspections, LLC  
ASHI Certified Inspector #261817  
P.O. Box 841  
Brunswick, ME 04011  
(207) 522-9938

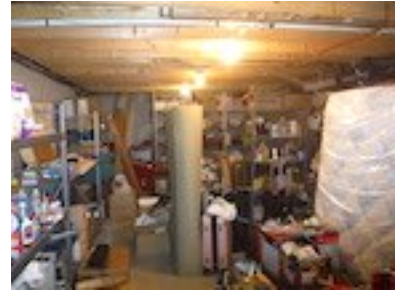
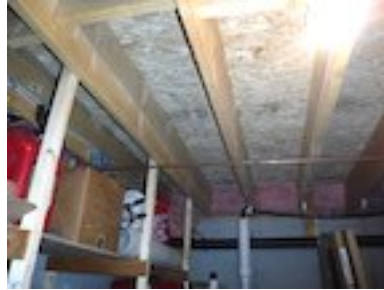
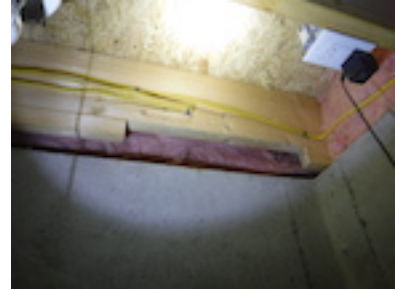
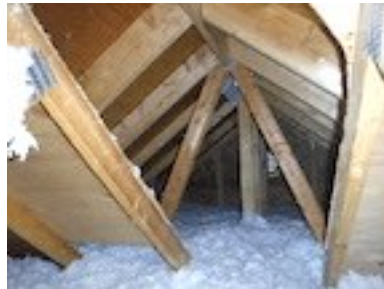
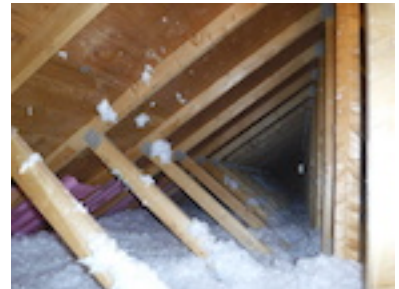
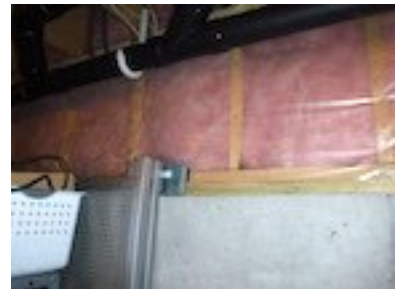
- No significant structural problems were observed.
- The attic was too hot to enter and could not be fully inspected.
- There were no indications of significant moisture problems in the basement.
- There is a plastic vapor barrier between unfinished and finished spaces in the basement, which is common for newer houses in this region. No problems were observed or suspected.
- No evidence of wood-destroying insect activity or decay was observed.
- Some structural elements were not visible due to insulation, stored items, and finished surfaces. No problems are suspected.

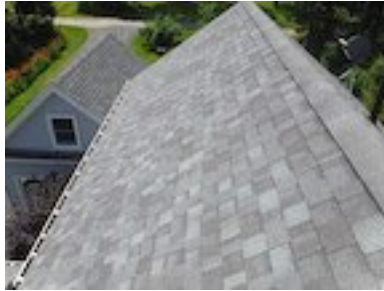
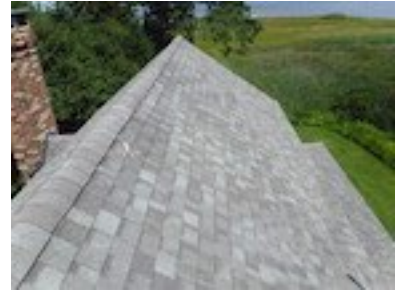
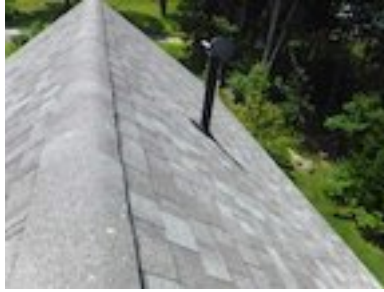
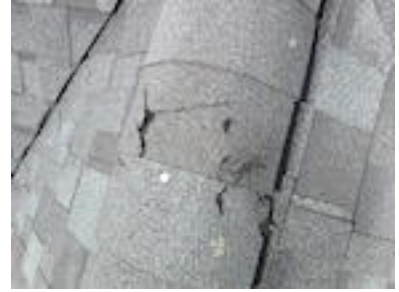
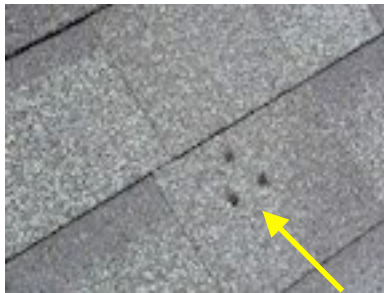
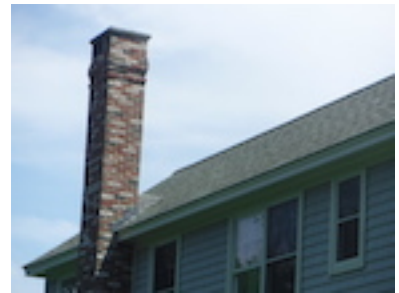
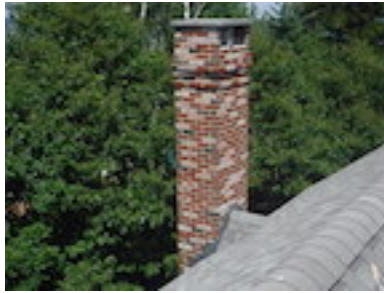
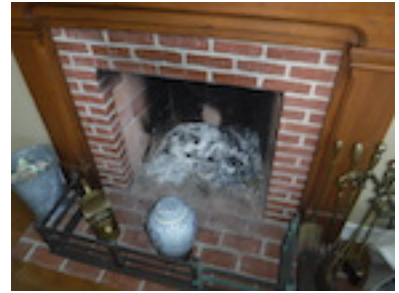
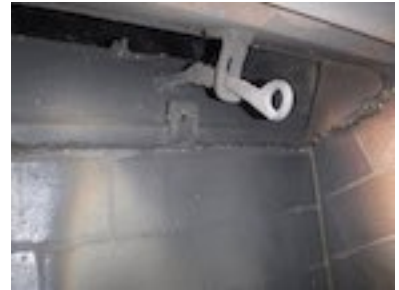
- Roof shingles are approximately 11 years old and in very good condition for their age with many years of service life remaining. No problems or evidence of leaking was observed. This type of shingle has an expected service life of 25-30 years.

- Several ridge shingles are deteriorated and should be replaced.
- Covering exposed fasteners with roofing caulk or sealant is recommended to prevent water from leaking through the nail holes. Several groupings of fasteners appear to be left over from the roofing staging being incorrectly installed.

- The fireplace is in generally good condition. A flue damper is installed and functional.
- The interior of the fireplace chimney flue was clear and unobstructed.

- Any chimney access in the basement has been paneled over with wood. A comprehensive interior inspection is beyond the scope of this report. Visible bricks and flashings are in good condition.

- The gutters are mostly clear, but there is a clog with plants growing in it on the southeast side. Overflowing gutters can deteriorate the house trim. Cleaning the gutters regularly is recommended.

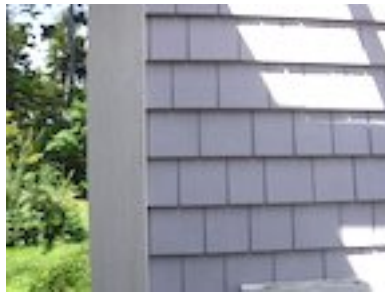
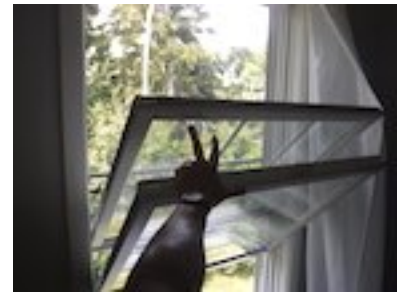
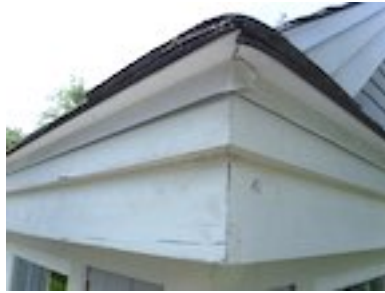
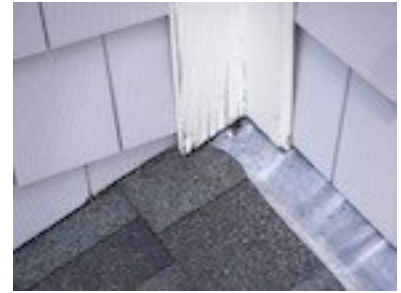
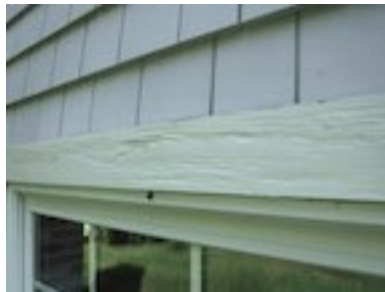
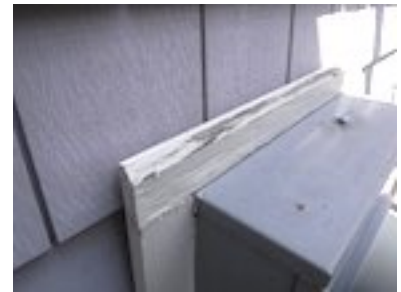
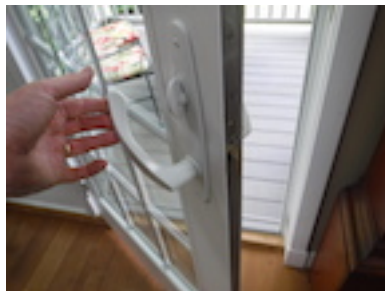
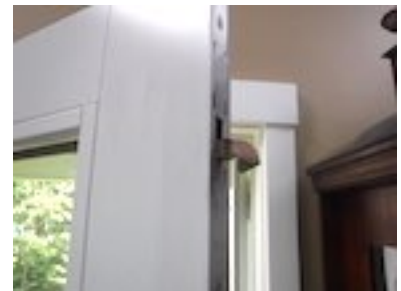
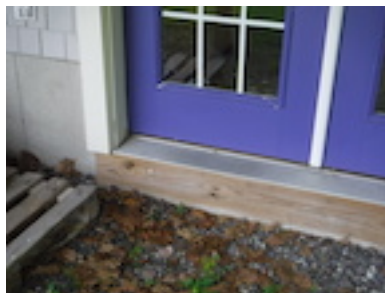
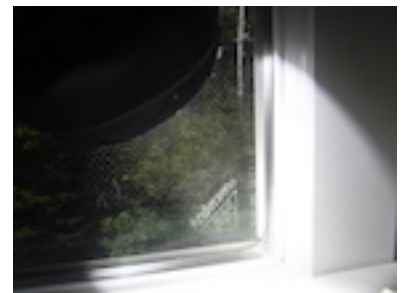
- The siding is in very good condition. No significant damage or defects were found during the inspection.
- Some small damaged sections and cracks in the trim should be monitored for water intrusion and patched or repaired as needed. The trim is due for painting in places. Wooden trim is deteriorated around several windows on the north side of the house, and should be repaired or replaced.

- The step up into the basement is high and could be a tripping hazard.
- The exterior doors to the porch are three position doors, and will not lock unless the handle is turned up.

- Grading around the house correctly slopes away from the home. No resultant moisture problems were observed.
- Exterior walkways and vegetation are in good condition.

- Plants in contact with the siding can trap moisture and accelerate deterioration. Consider cutting back plants near the home.

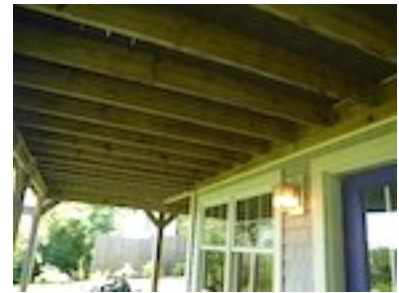
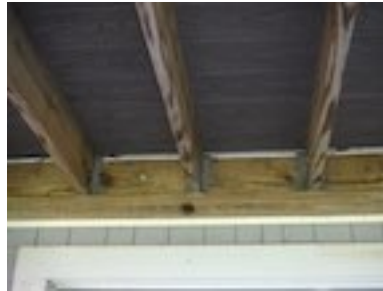
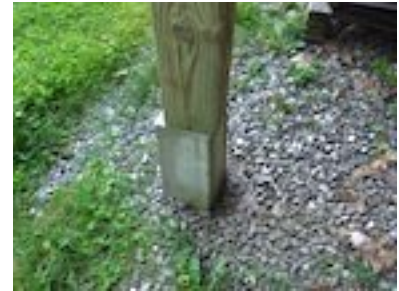
- The deck attached to the house is made of pressure-treated lumber. The deck is bolted to the house and joist hangers are used, as is recommended. The deck posts are resting on concrete footers. No problems were observed.

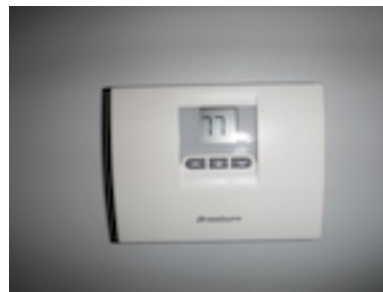
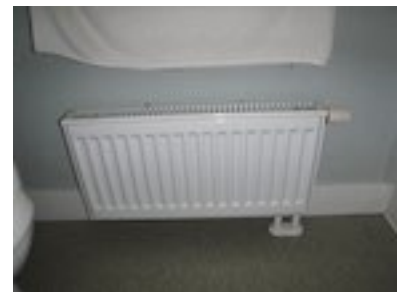
**Heating System Type:** Propane fired wall mounted, on demand hot water boiler, likely a BAXI brand with thermostat controlled forced hot water radiator and radiant floor distribution

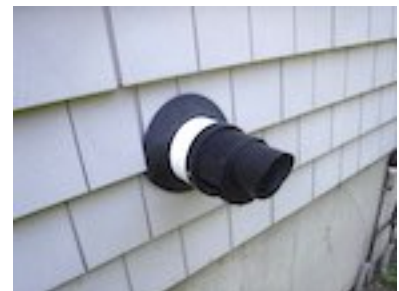
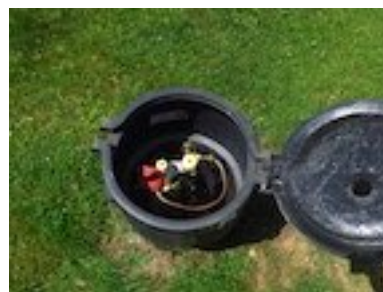
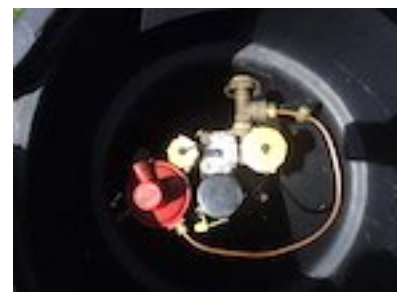
- The central heating system ran smoothly and responded to controls. No service logs were found during the inspection. Recent service is reported. Annual service by a qualified technician is recommended if not done so in the last year.
- Keeping the furnace air intake and exhaust pipes free from snow in the winter is recommended.
- This boiler creates condensate, a corrosive liquid, as a byproduct of combustion. There was no visible neutralizer installed. Having this furnace further evaluated by a qualified professional is recommended.
- A buried 500 gallon propane tank is installed on the north side of the house. The fuel gauge and gas shutoff are located on top of the tank.

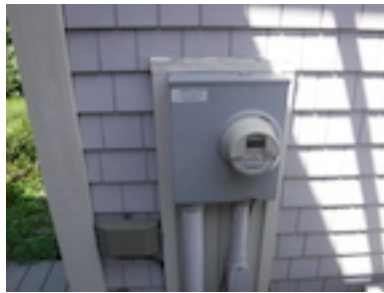
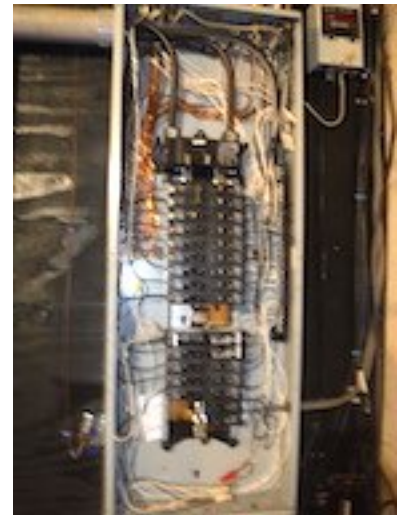
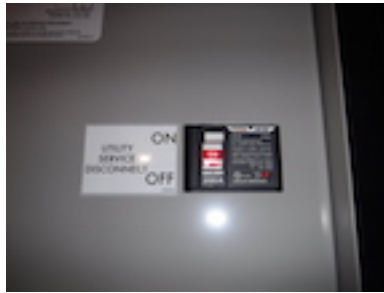
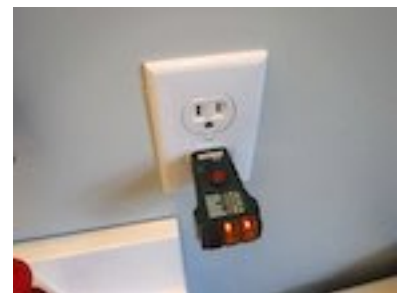
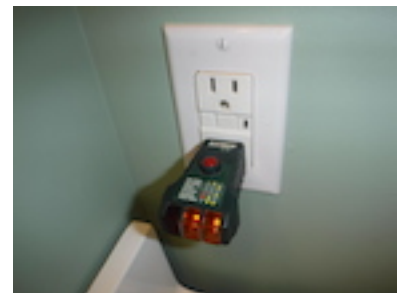
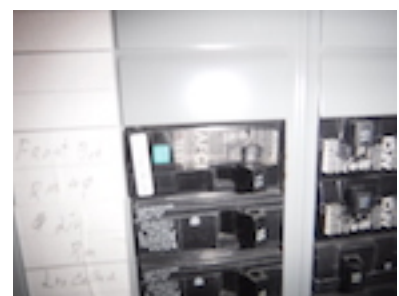
- A representative number of outlets and switches were operated during the inspection. No electrical problems were discovered.
- The main distribution panel cover was removed to inspect the interior. No electrical problems were observed.
- GFI and Arc-fault breakers correctly tripped when tested.
- Adding a protective conduit to the exposed electrical wire at the base of the lightest by the garage is recommended to prevent the wire from being damaged or becoming disconnected.
- A propane-fired fully automatic Generac generator is installed behind the house. The generator started automatically when the power was shut off at the generator panel. Refer to the owner's manual for operating and service instructions.

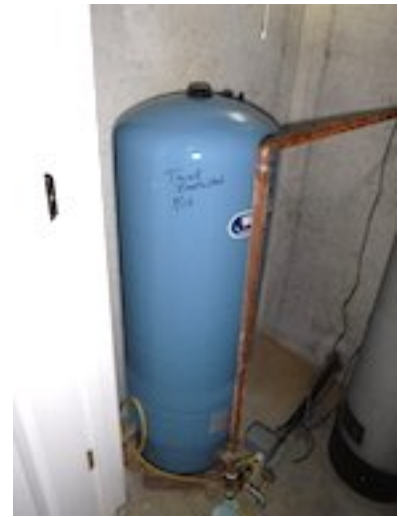
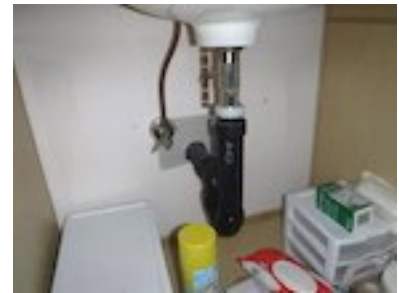
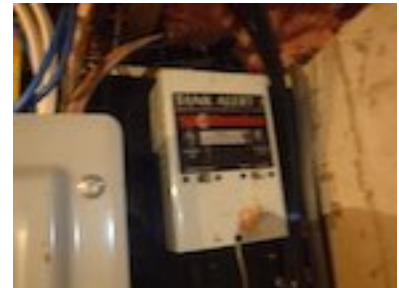
- The main water shutoff is adjacent to the well pressure tank.
- A water treatment system is installed but its purpose is unclear. Refer to the Owner's Manual for operation and service instructions. Obtaining the Installer's name is also recommended.
- Water supply and drainage worked well in all bathrooms and the kitchen.
- The septic system was inspected by Bill with Advanced Leachfields.
- A septic pump alarm is installed in the basement.
- The domestic hot water in the bathroom sink reached 129° Fahrenheit, which could cause injury and scalding. 120° Fahrenheit is considered the maximum safe hot water temperature. The water temperature can be controlled on the heating coil on the hot water boiler in the basement.

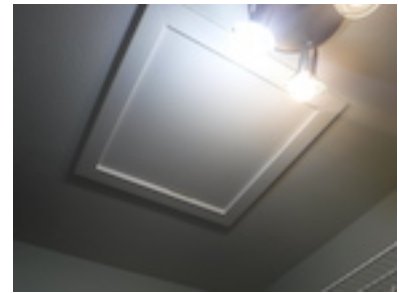
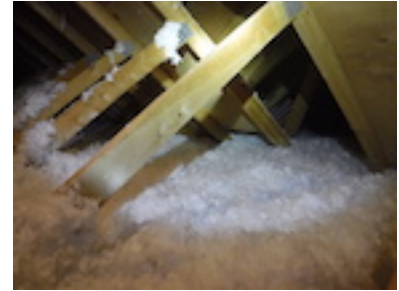
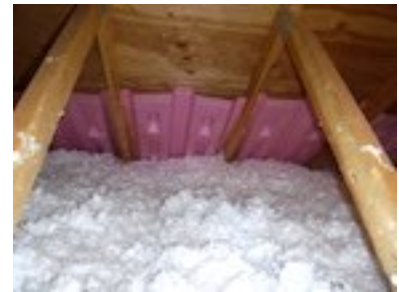
- Attic insulation levels may meet the standards for a house of this age, but would be considered moderate by today's standards. There are some areas in the attic with little or no insulation. Adding additional insulation is recommended.
- No signs of condensation problems were observed on the roof sheathing in the attic.
- The attic was very hot. Current building practices recommend that there is no more than a 20° Fahrenheit difference between attic temperatures and exterior temperatures. Large differences in temperature can deteriorate shingles and cause additional problems for houses. Adjusting the ventilation may help to encourage airflow through the vents.
- The paper facing on fiberglass insulation batts in the basement ceiling is exposed, and is flammable. The manufacturer's printed notice on the paper facing states that it needs to be covered.

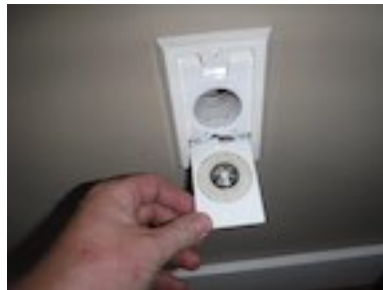
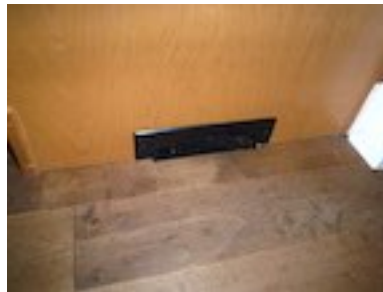
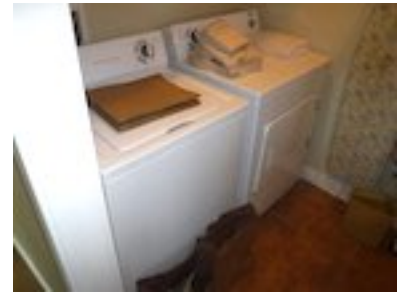
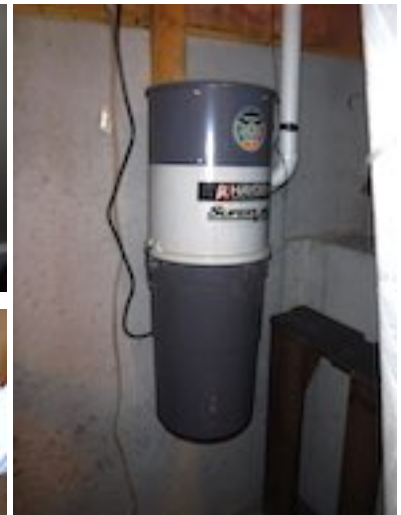
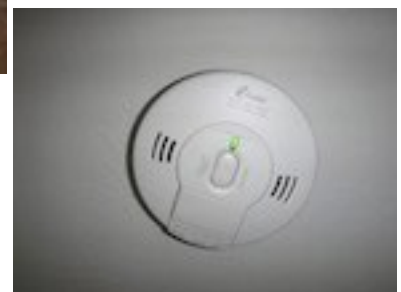
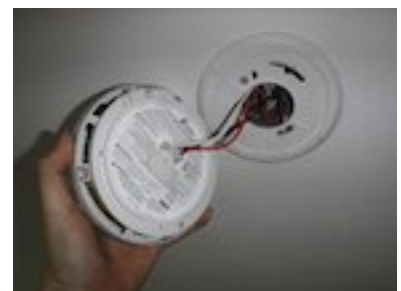
- Kitchen appliances were tested for basic operation only. No problems were observed.
- Most interior surfaces including walls, ceilings, and floors are in generally good condition with some minor cosmetic repairs needed in areas.

- Door stops would prevent damage to wall surfaces.
- The drywall has cracked above the master bedroom door, and the door does not shut fully. It is possible that the house has settled slightly in this area. There were no other indications of settling in the house. Adjusting the door, repairing the drywall and monitoring this area for further movement is recommended.

- Laundry appliances were operational. The dryer is a gas-fired dryer. A dryer vent to the exterior is installed as recommended.
- A central vac system is installed in the house and was functional when tested. A kickplate vac terminal in the kitchen was not functional when tested.

- Hardwired, interconnected smoke and carbon monoxide detectors are installed in all recommended locations and were functional when tested. Replacing all smoke detectors over 10 years old is recommended.

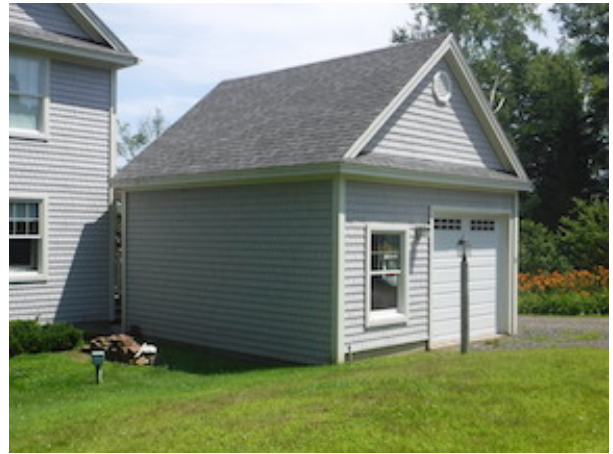
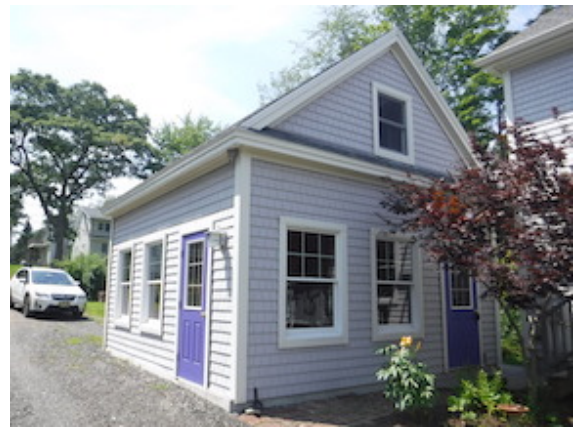
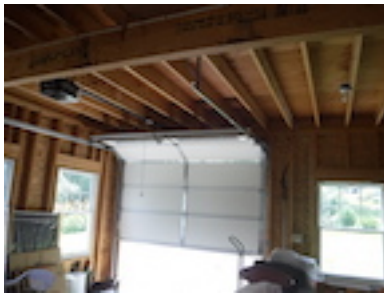
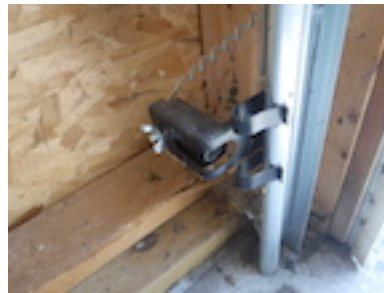
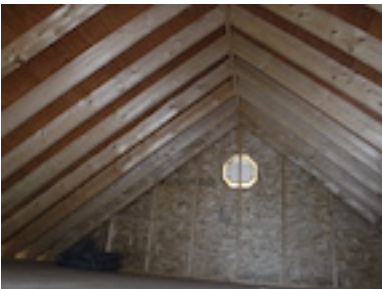
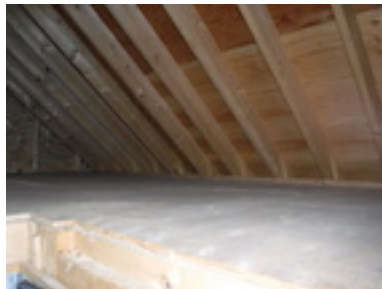
- The garage door opener was functioning as intended, with auto-reverse optical and pressure safety sensors installed and operational.
- Dates printed on the garage sheathing indicate that the garage was likely built in 2012.
- The string to the pull down stairs in the garage broke when it was pulled.
