BUILDING INSPECTION REPORT

Inspection Date:
Wednesday, October 30, 2019

Prepared by:
Ray Mayo
ASHI Certified Inspector #261817
Mayo Home Inspections, LLC
P.O. Box 841
Brunswick, ME 04011
(207) 522-9938

The inspected property consists of an approximately 140 year old 2-story wood framed Colonial style house with an attached garage. The house is serviced by a private water supply and a private septic system and is considered to face South.

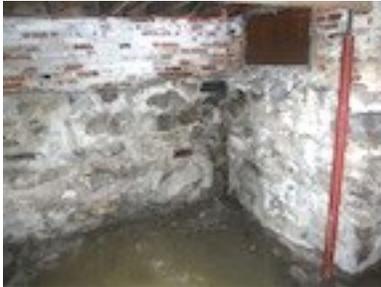
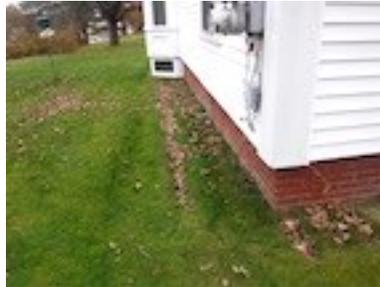
- Moisture enters the basement periodically and there was some standing water in the basement. The basement is designed to Chanel moisture to a foundation drain, but reducing or preventing moisture from getting into the foundation in the first place is the best course of action, either by regrading the land to shed water away from the house, and/or adding gutters (especially on the south side of the house). Controlling moisture created in the basement by draining the hot water heater and the water softener directly into the foundation drain and running a dehumidifier after fixing all other sources of moisture is also recommended. There is also evidence of moisture running down the north chimney, and adding a cover to divert rain would prevent this moisture from ending up in the basement.

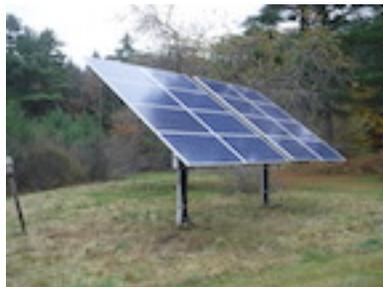
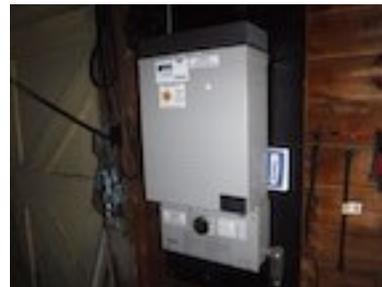
- A photovoltaic system is installed, with two ground-mounter PV panels, and an inverter installed in the garage. Refer to the Owner's Manual for operation and service instructions. Obtaining the Installer's name is also recommended.

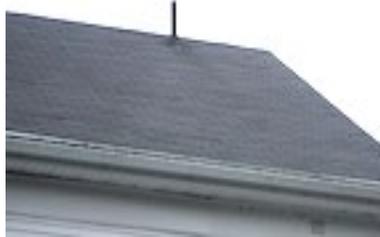
- Repointing the chimney bricks in the attic is recommended to prevent them from becoming loose. Having both chimneys fully evaluated by a qualified professional is recommended.

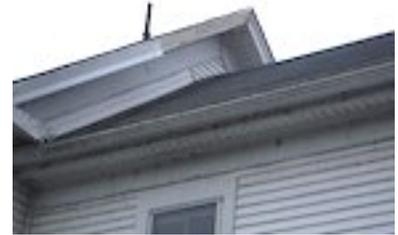
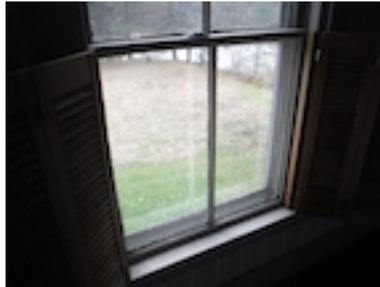
- Two windows have disconnected sash cords. The counterweights on the sides of the windows, in the jambs, keep the window panes in place. If the sash cords break or become disconnected, the windows can slam down, causing injury or damage. Repairing or replacing damaged or missing sash cords is recommended.

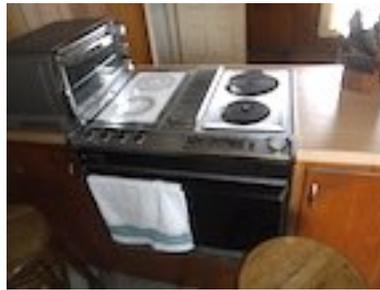
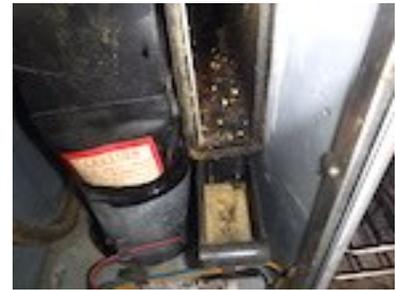
- The stove is very old, very dirty, and was not tested. The refrigerator was functional.
- Most interior surfaces including walls, ceilings, and floors are in generally good condition with cosmetic repairs needed in areas.

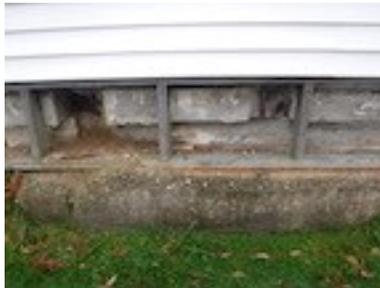
- The garage trim is missing or deteriorated in many places.
- The garage door opener was functioning as intended, with auto-reverse optical and pressure safety sensors installed and operational.
- Current codes require fire-rated walls and doors be installed between garages and living spaces. This house does not have such a fire barrier. The house is not required to have one installed due to its age, but it is recommended.
- The stairs up to the house from the garage could be a significant trip or fall hazard.
- There is evidence that several garage floors have been poured on top of each other, indicating that the garage floor has likely settled and sunk over time. Large cracks in the garage floor could indicate that the subflooring was not correctly compacted, or that water has gotten under the slab.
